**Generalized Synthetic Pump Cards**

**Echometer Help Center  
(Technical Note)**

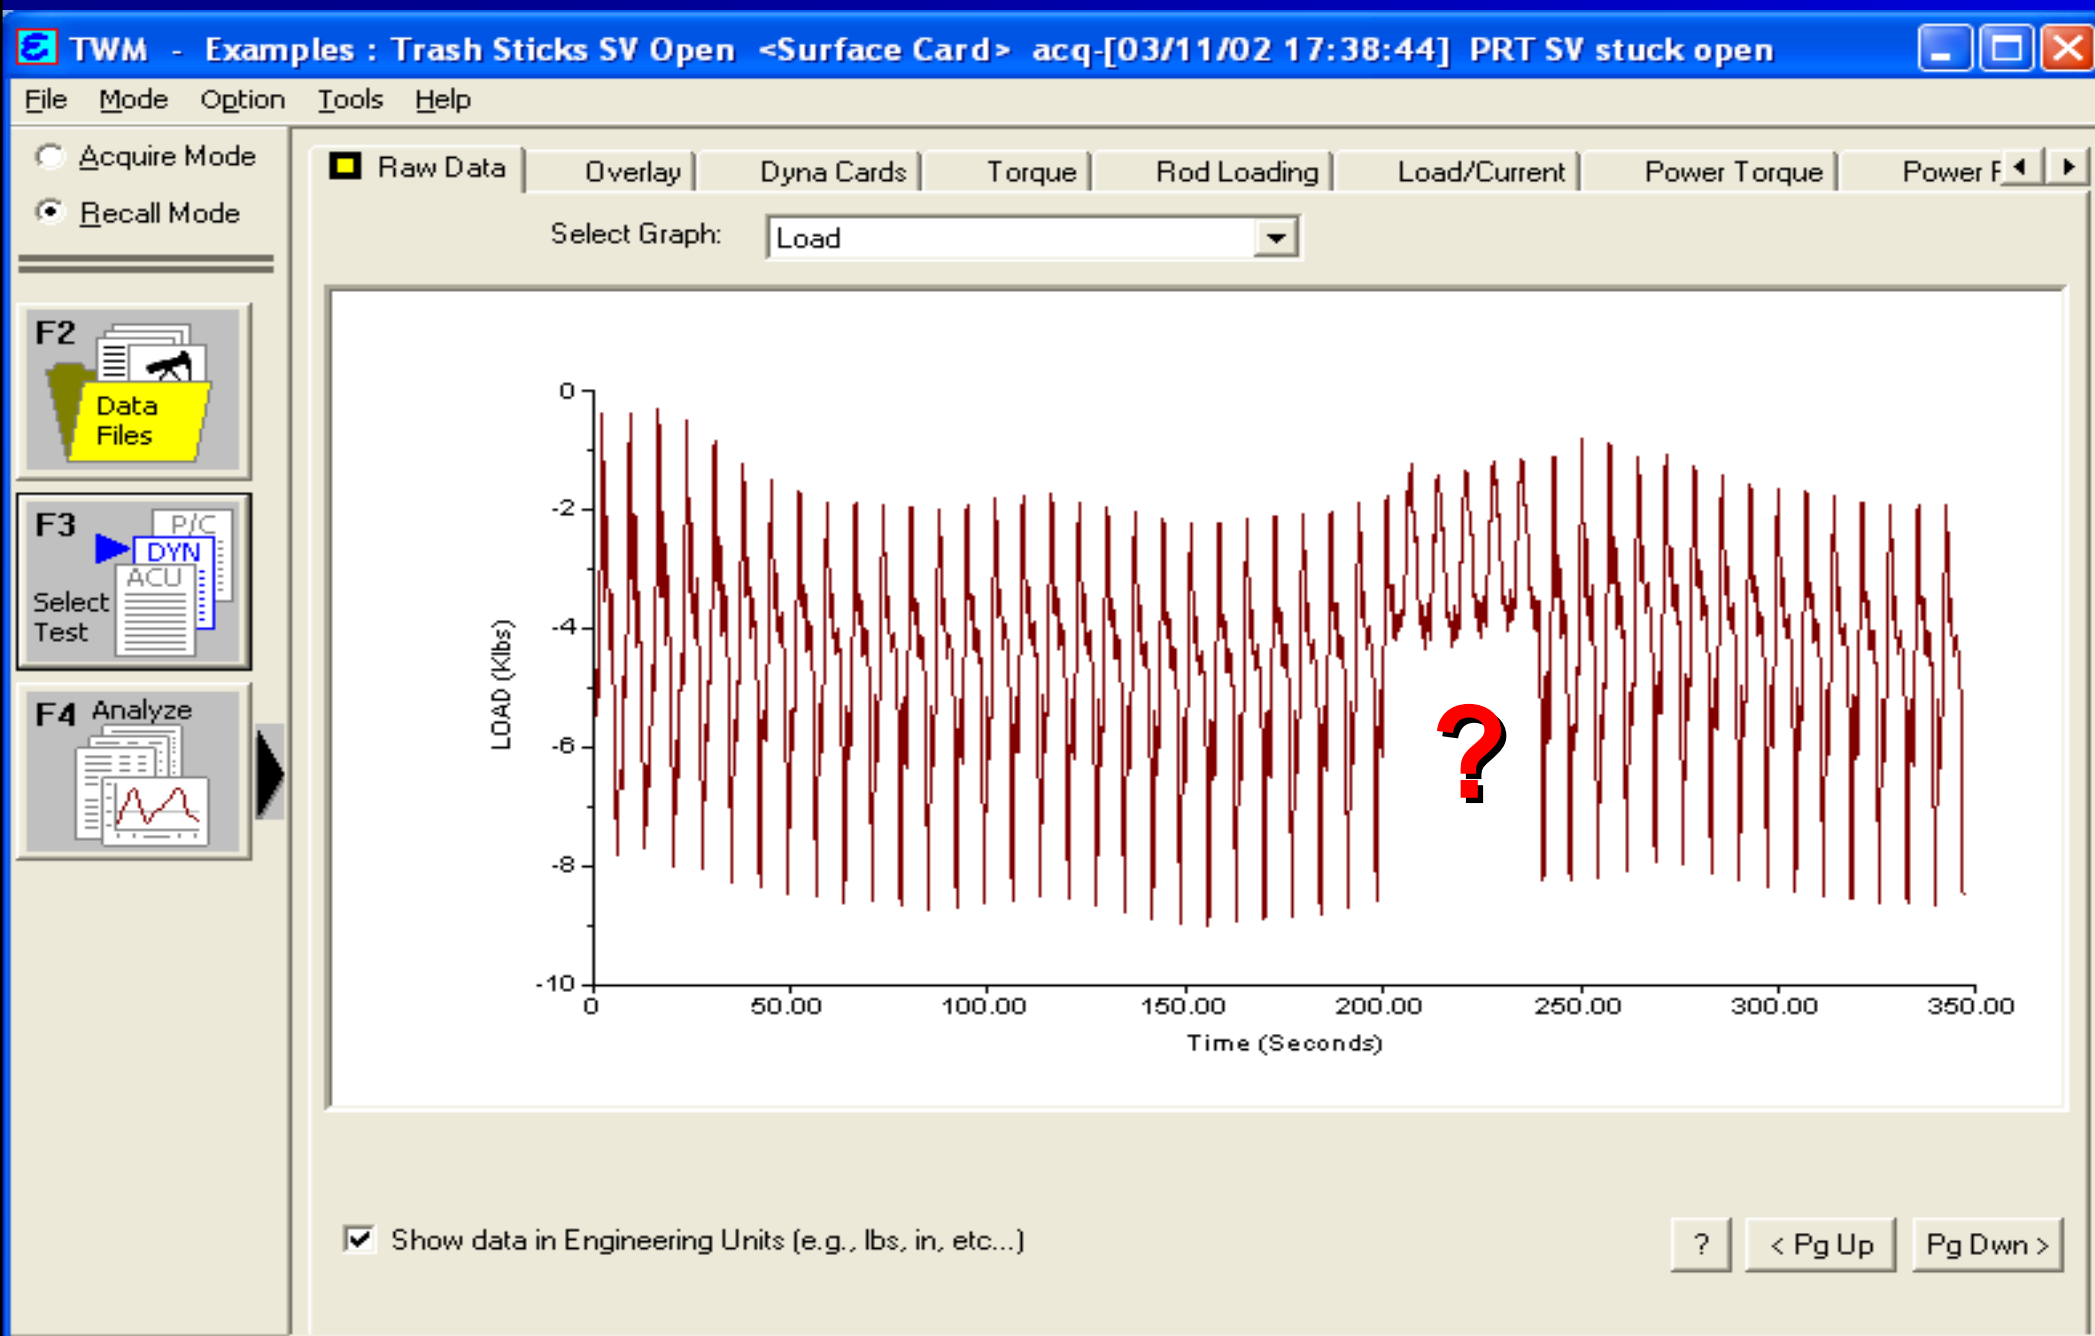
## Strokes 29-34 SV Missing

# SV Sticks Open

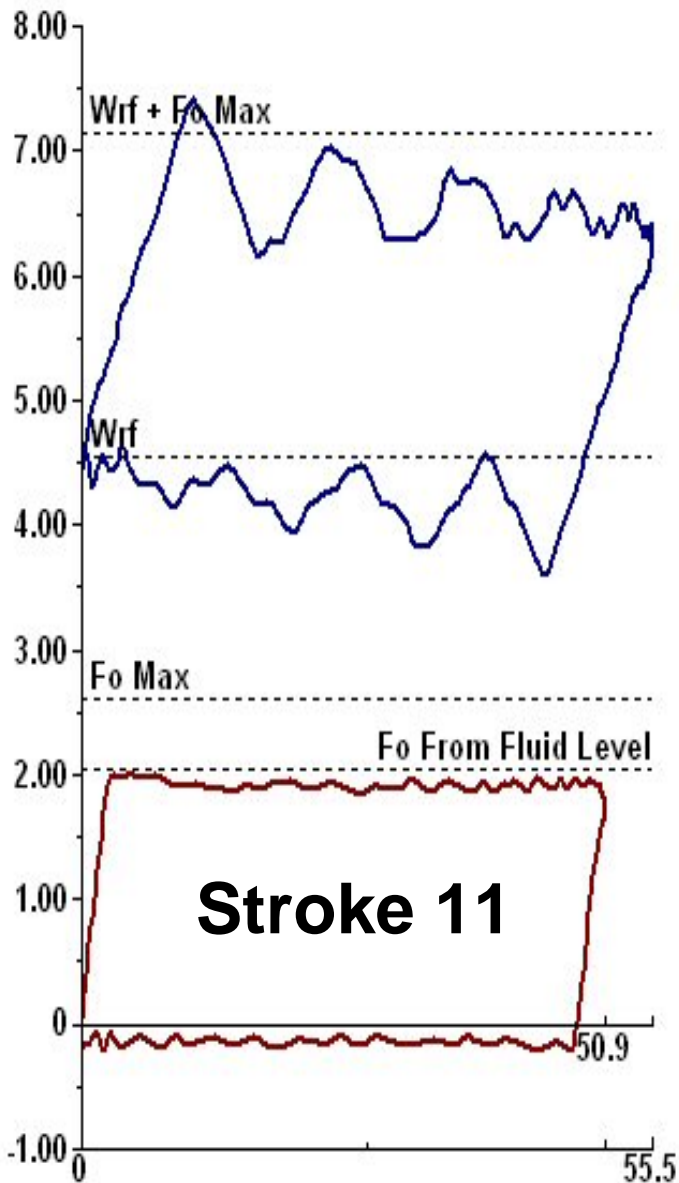
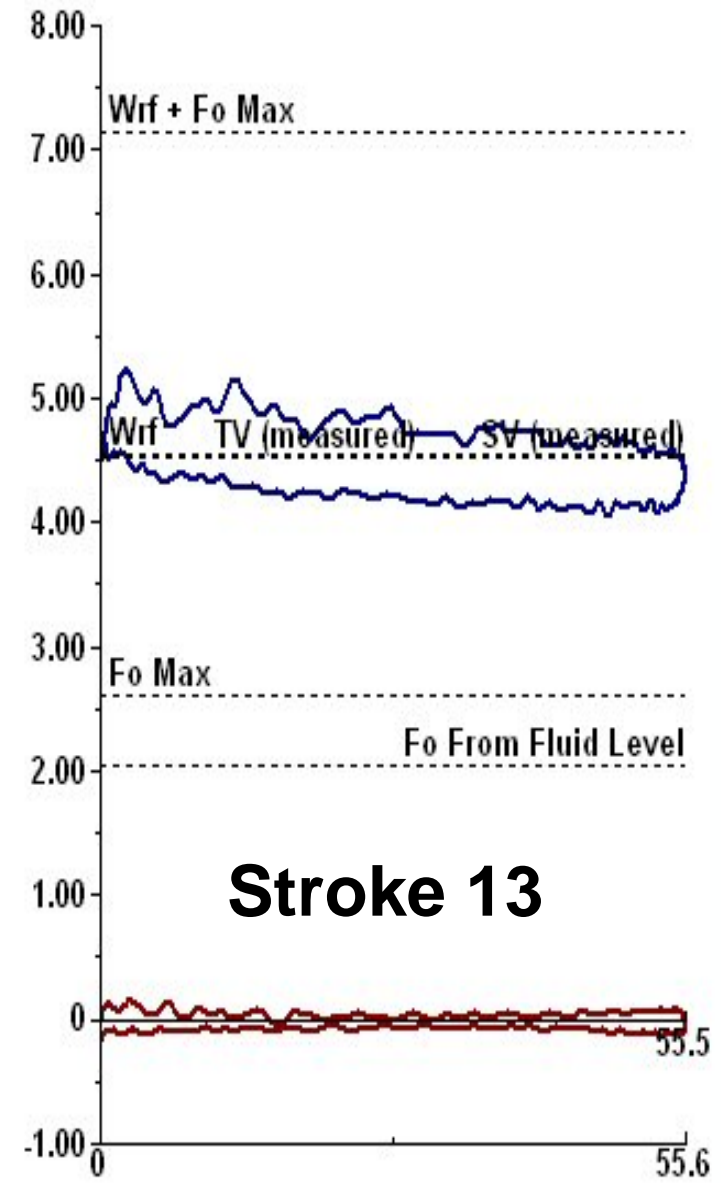
# Lost TV Load

Strokes 10 seconds apart.  
Is this a deep Rod Part?

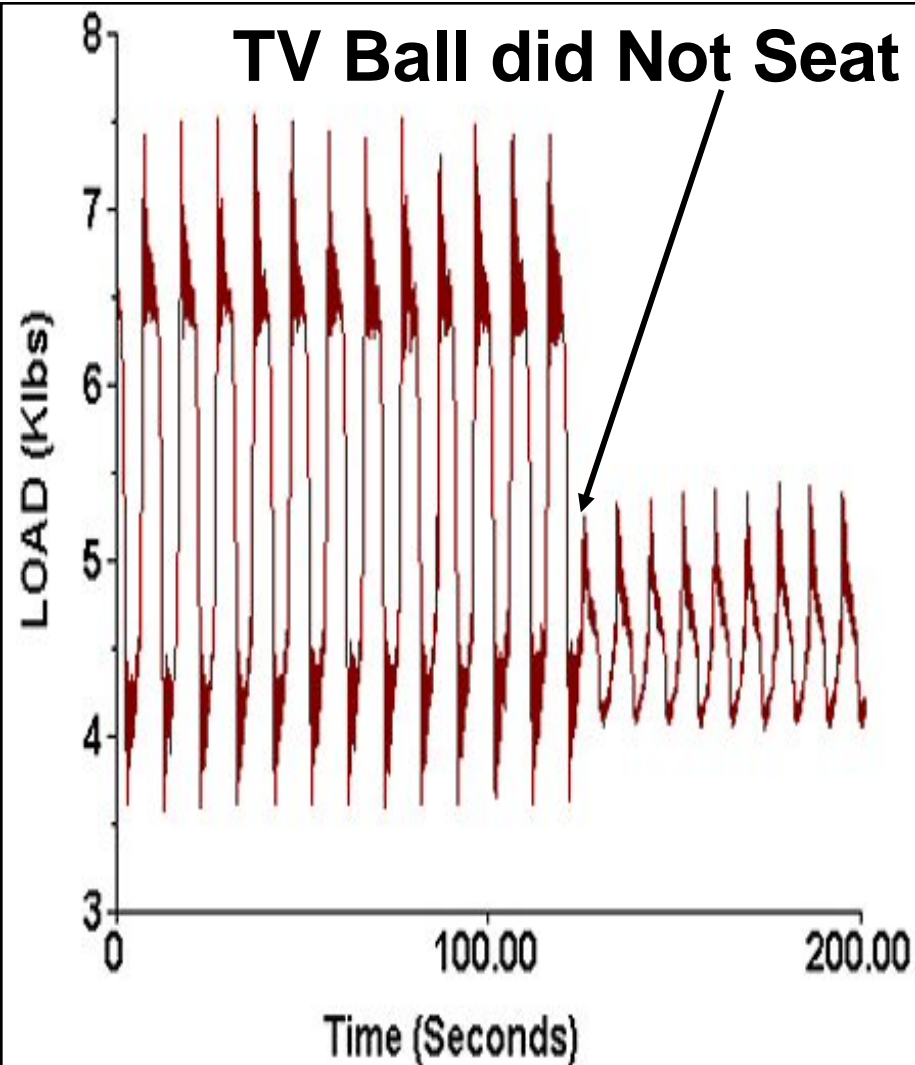
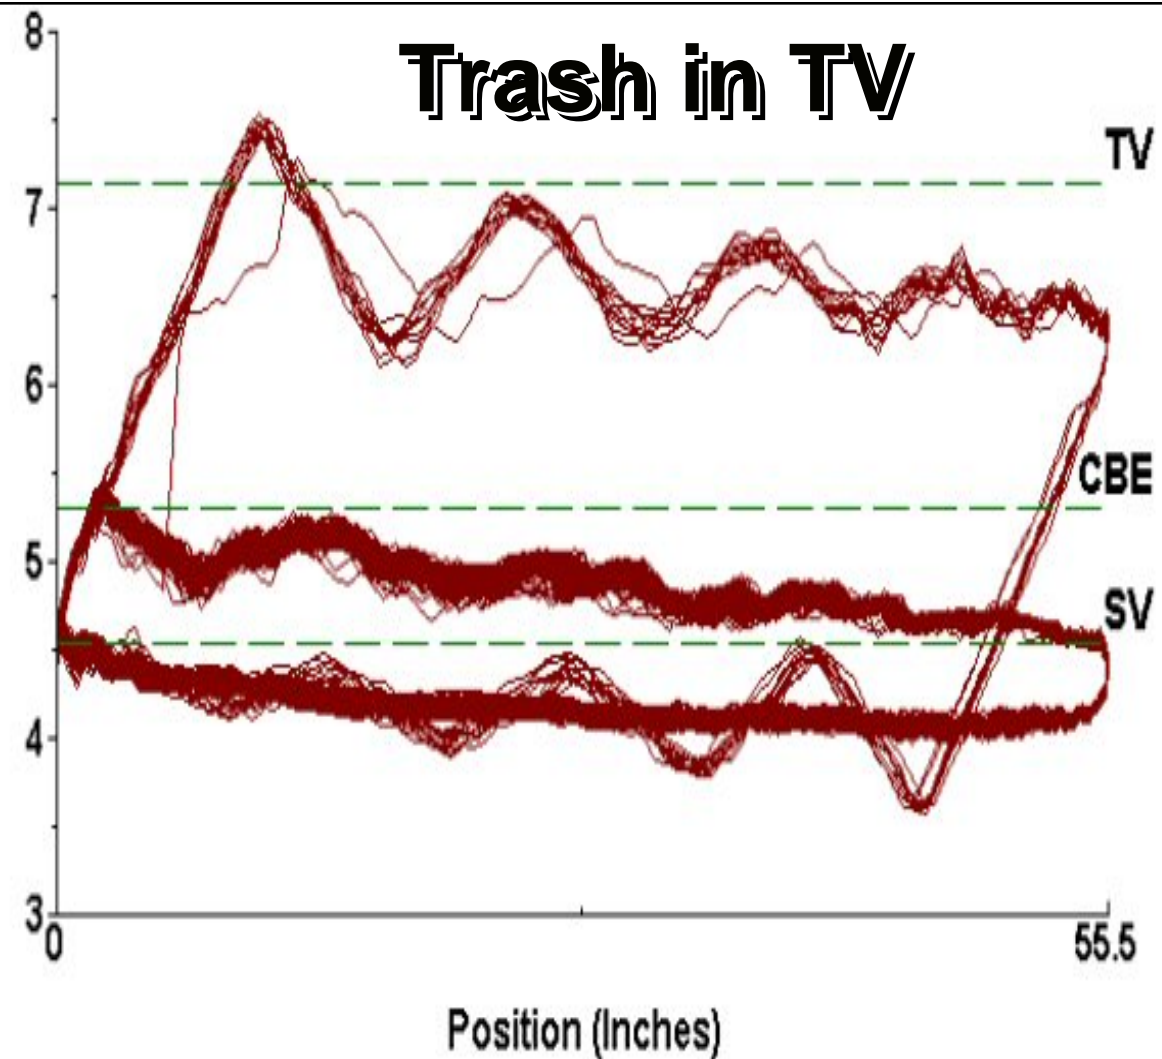
**Trash in TV** Notice normal appearing Surface Dynamometer Card, on the 13<sup>th</sup> stroke TV became stuck open due to trash. Same type of surface card could occur, if Pump unseated, Pull Rod became unscrewed or parted, or rods parted at the pump.

Sometimes trash in the pump keeps the traveling valve ball from going on seat. Tagging on the down stroke before pulling, may knock out trash.

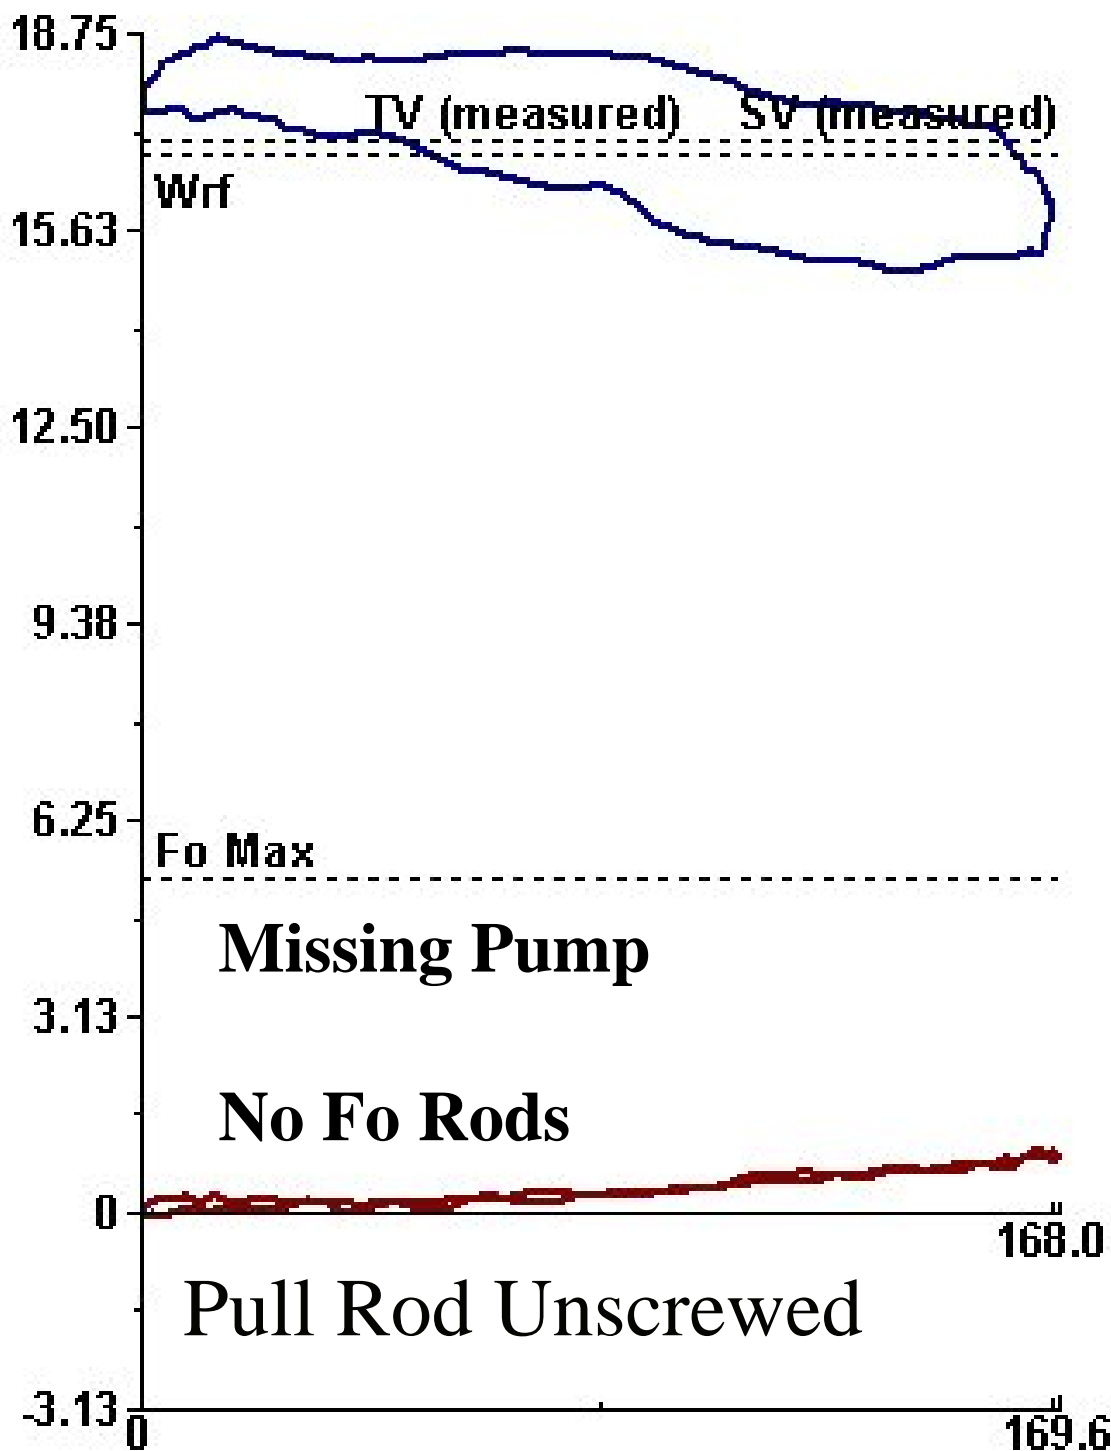
## Rods Parted at Pump

No fluid load from pump being applied to rod string. Parted rods are overtravel cards, because there is no loss of downhole stroke due to the static stretch of rods picking up fluid load. Measured surface dynamometer card loads are near standing valve load (Wrf).

Note that both the standing and traveling valves measured test loads are at the calculated standing valve test load.

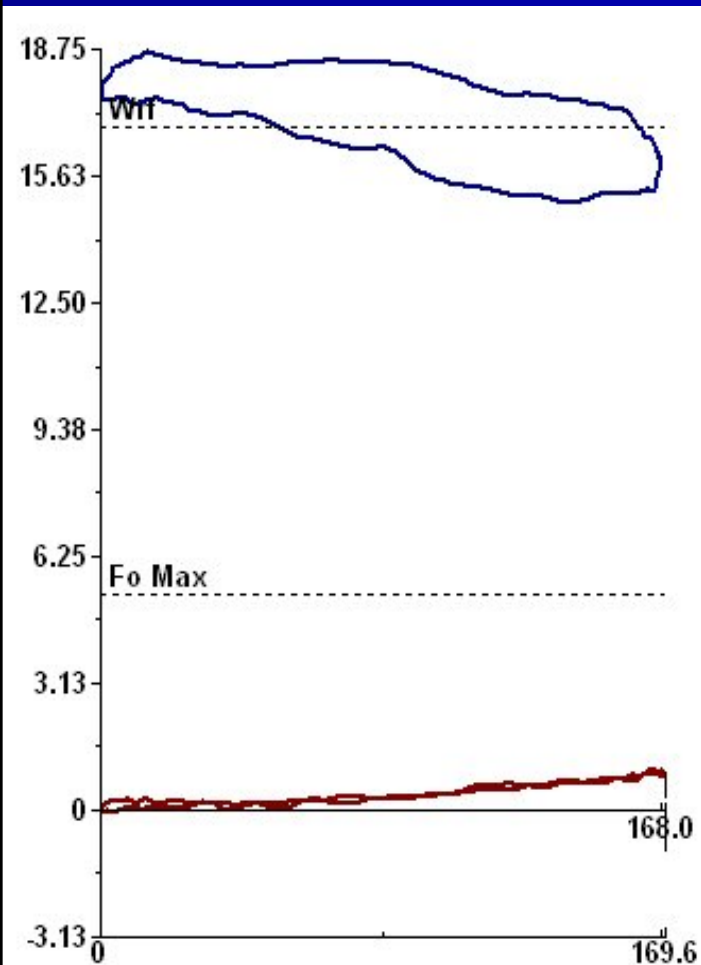
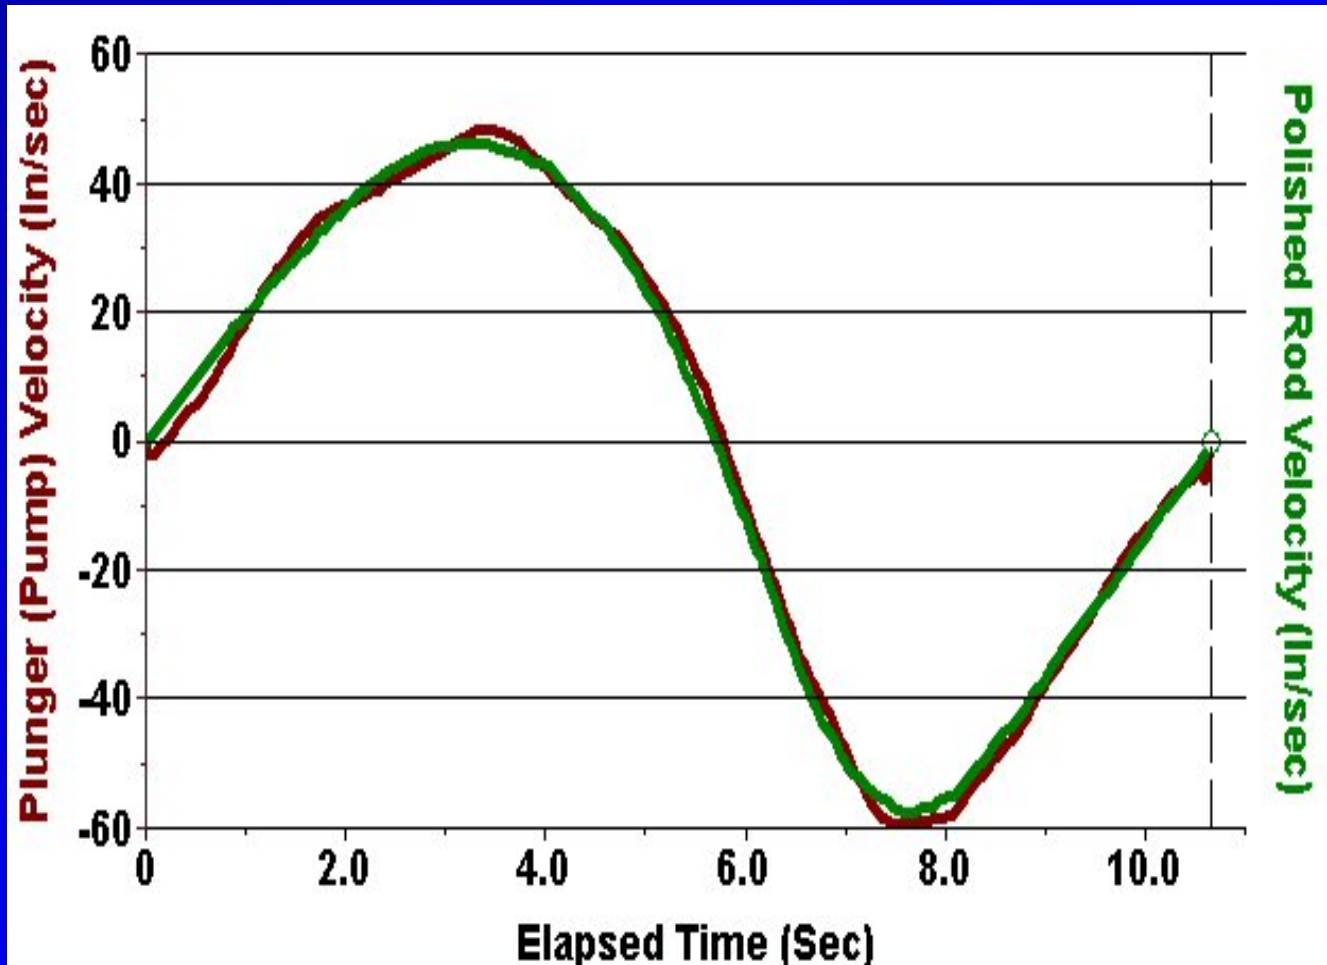
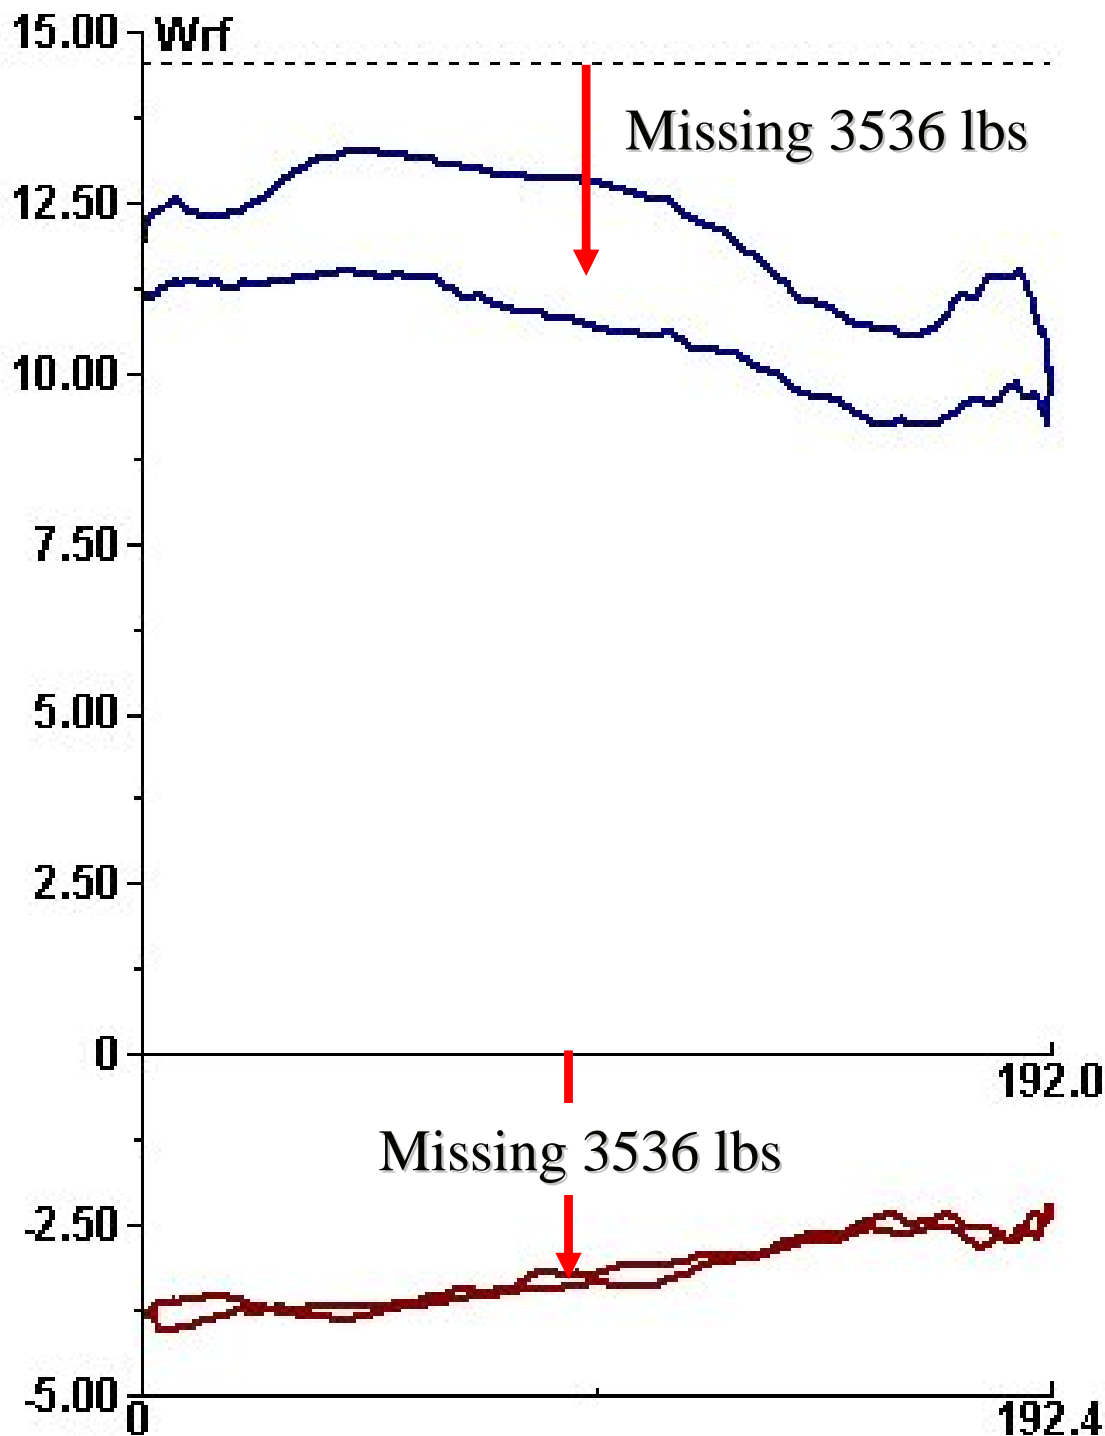
# Deep Rod Part

# Pull Rod on Pump Parted

## Plunger & Polished Rod Velocity Equal

1. No Fluid Produced to Surface
2. No Fluid Load – No Pump – No Rod Stretch
3. Plunger Does Not Stop while Rods Stretch
4. Momentum of Rod String results in Slight Over-travel of Rods at Pump Depth

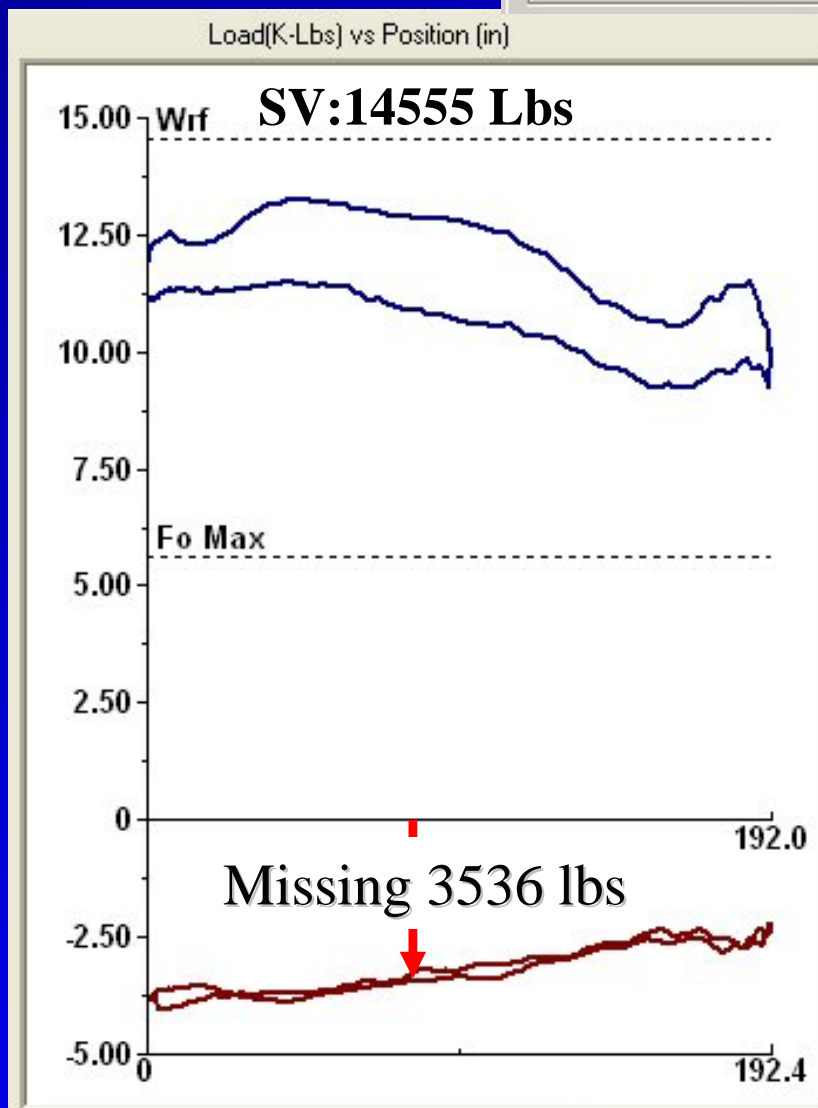
# Missing 37 3/4" Rods Parted 5365'

**Rods Parted Higher Above Pump** results in dynamometer cards load measured below weight of rods in fluid. The actual location of the rod part will determine the trace's relative position with respect to the theoretical weight of rods in fluid.

Rod parted at a depth of 5365 feet results in 3536 lbs missing weight of rods in fluid.

Pump Card  
Sets Below the  
Zero Load Line  
By Weight of  
Missing Rods

Missing:  
Wrf 3536 lbs

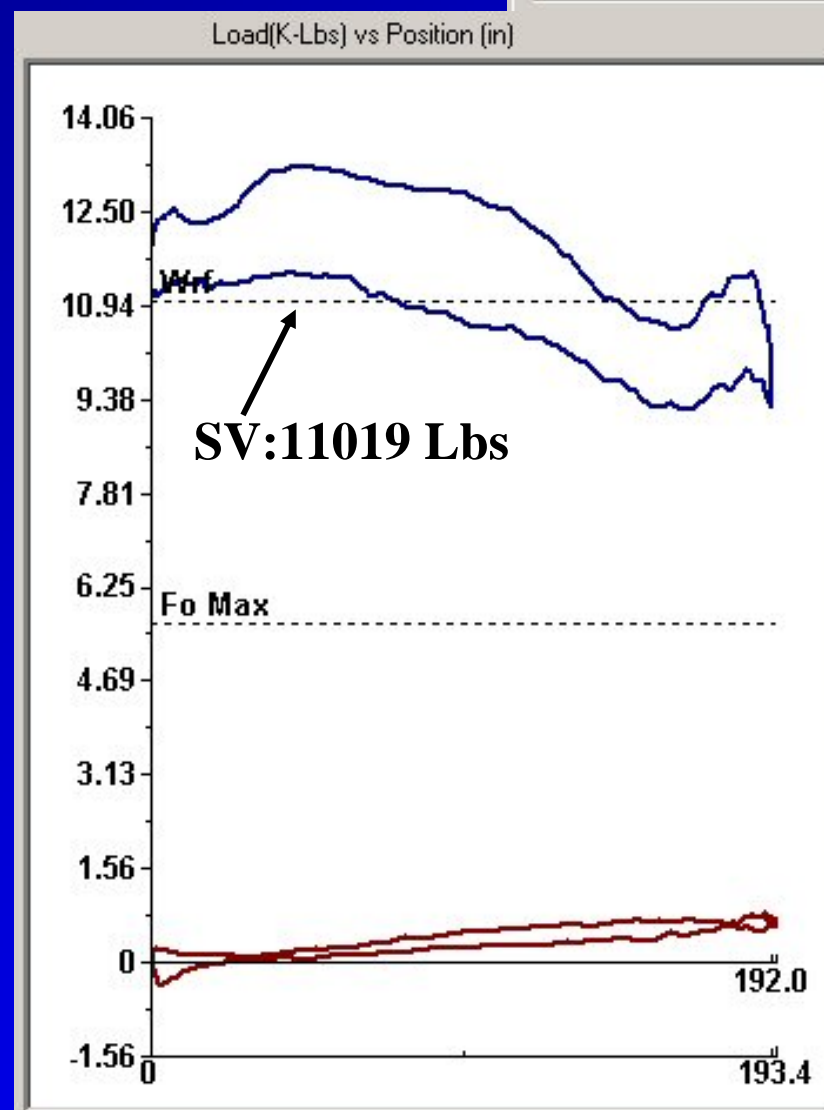
# Missing 37 3/4" Rods Parted 5365'

Adjusted Rod Length, then Pump Card sets on Zero Load Line

No Pump  
No Fo Rods

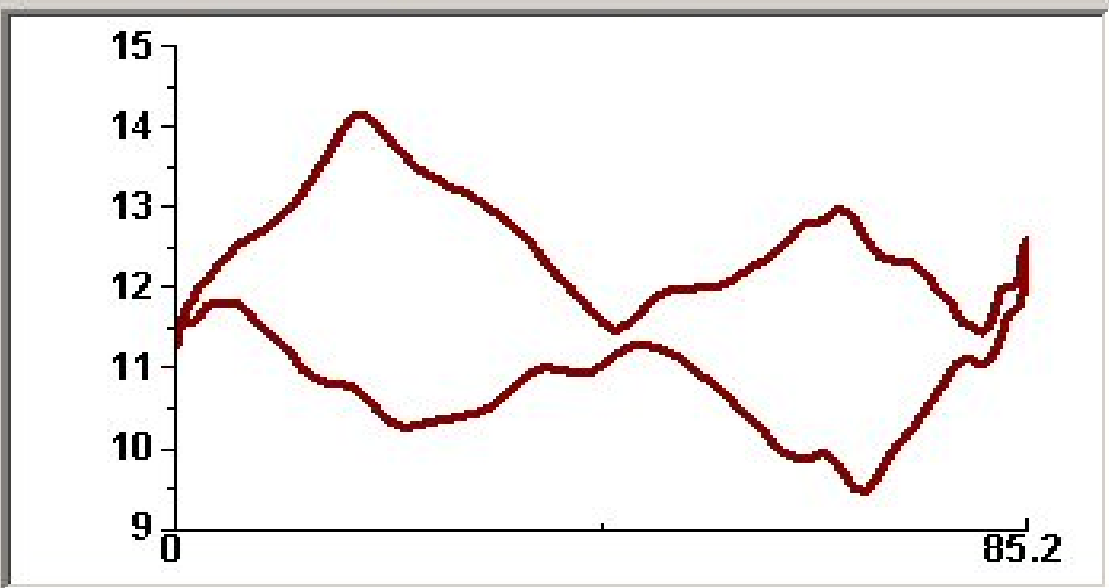
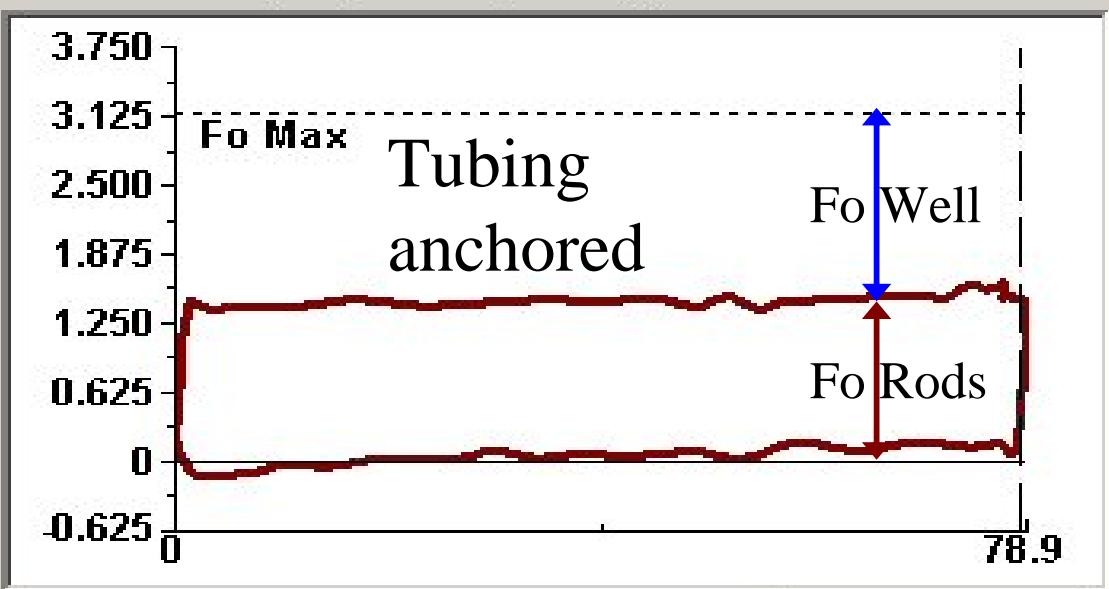
# TV OK - Tubing Leak, No Fluid to Surface

Hole in Tubing is detected using dynamometer, because Net Lift shown by the pump card Fo is much less than Fo required by fluid level and full pump card's valves are OK .

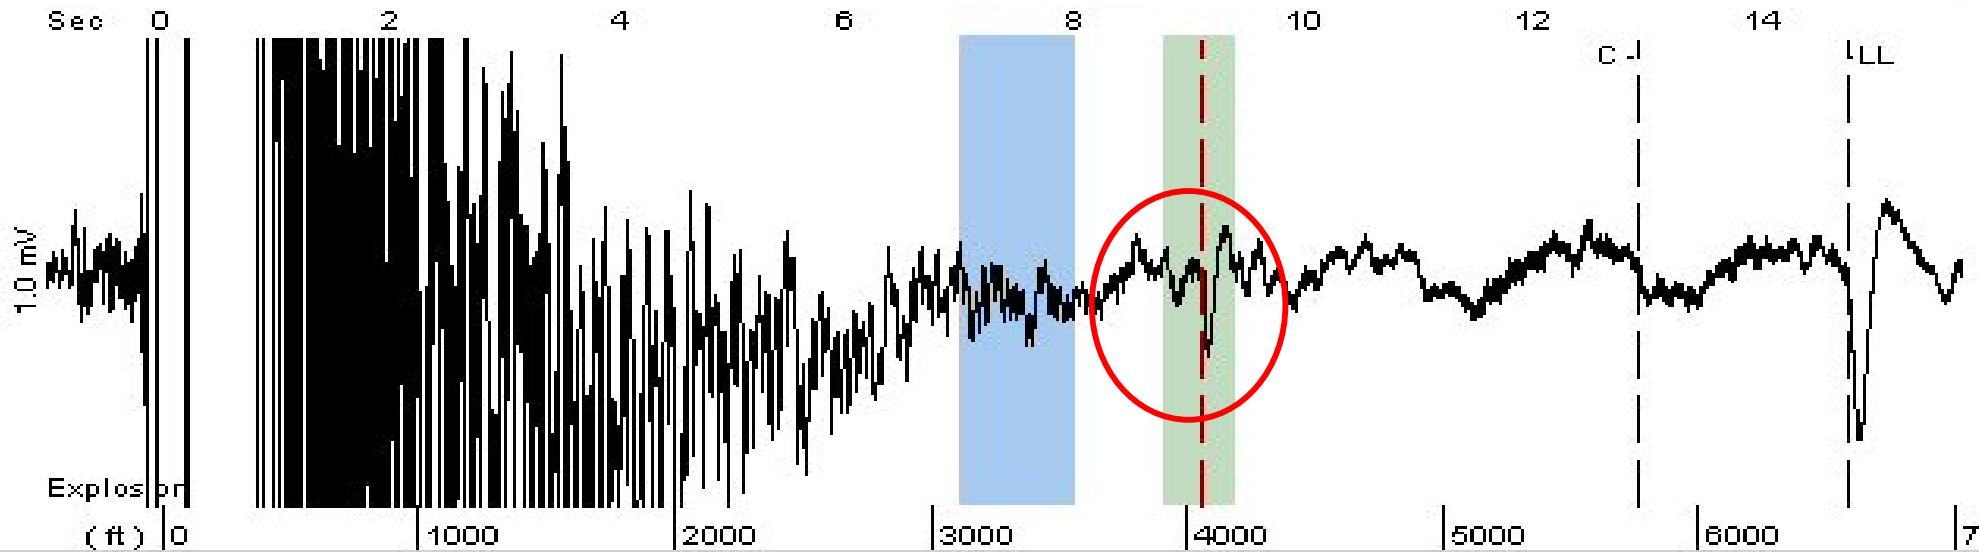
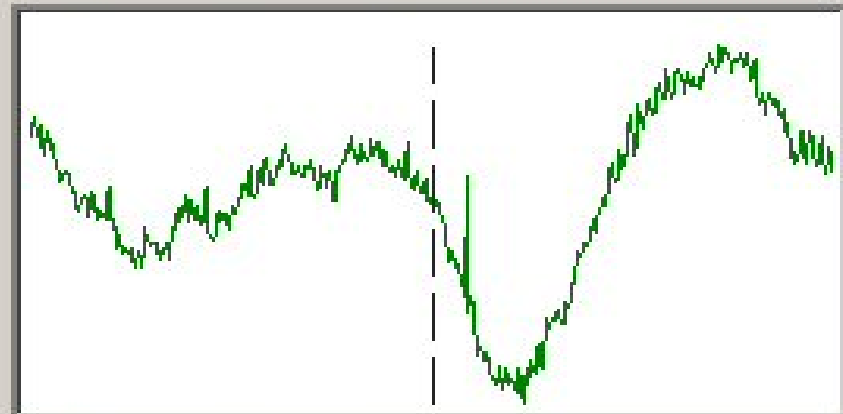
# Fluid Level: Split Tubing Joint 4052'

Split Tubing Joint	4000'
Fluid Level	6583'
Pump Depth	6975'
<b><u>Net Lift</u></b>	<b><u>2583'</u></b>

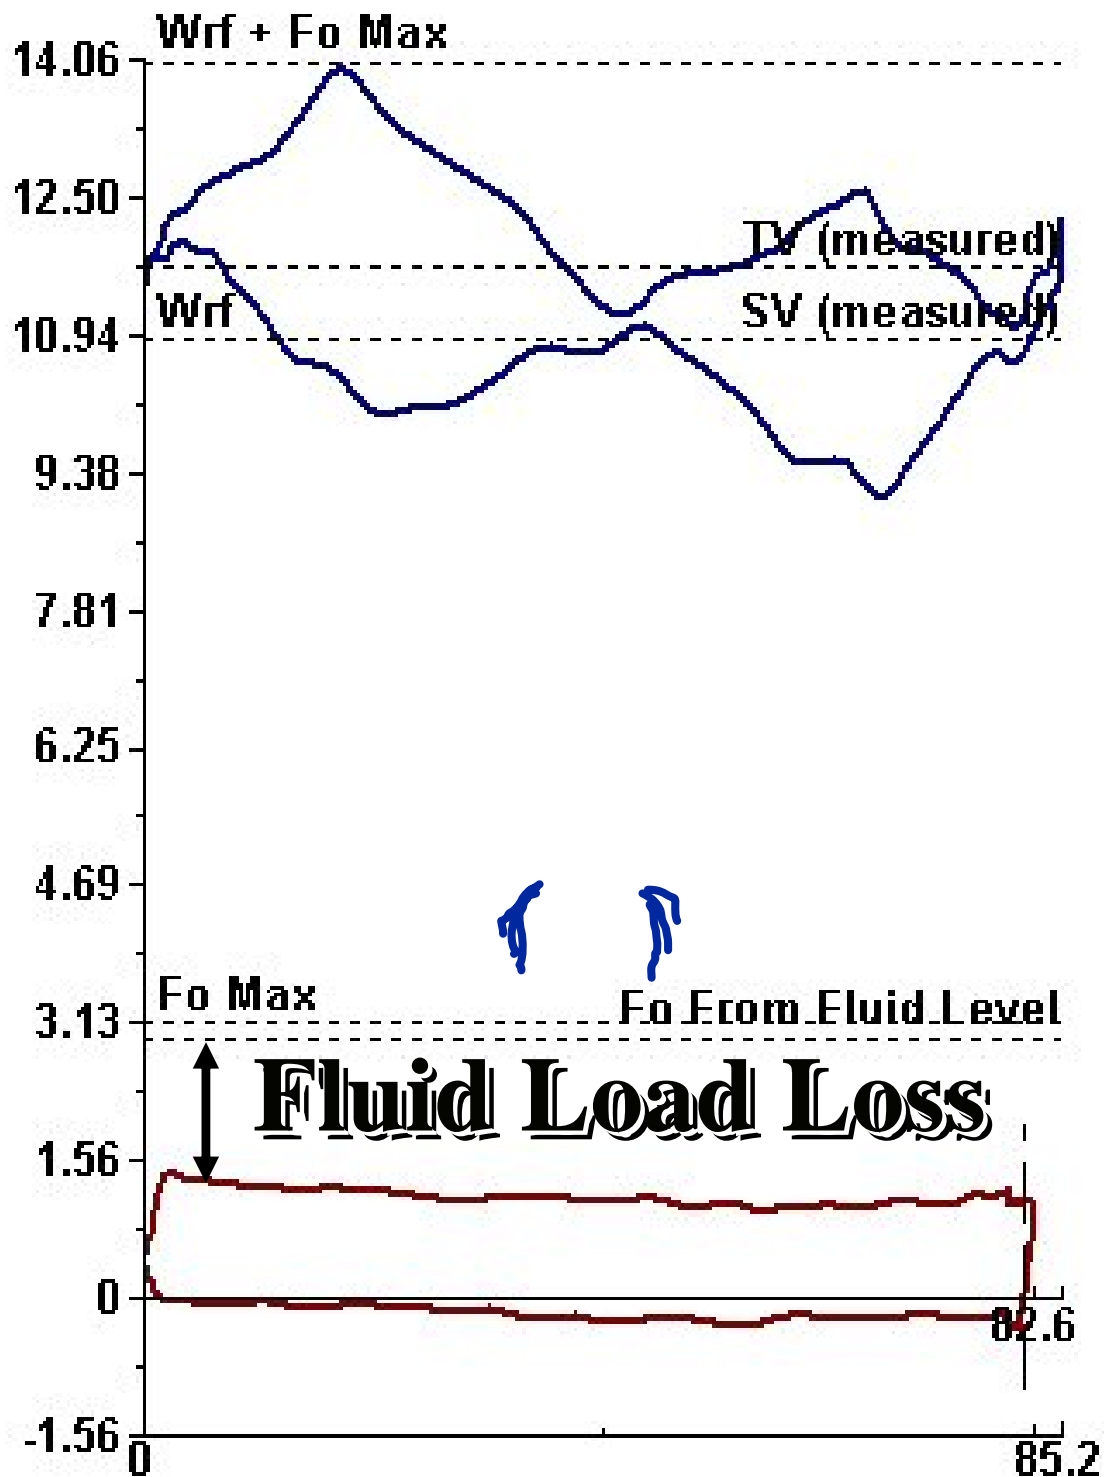
**Fluid Load Loss** reflects a surface dynamometer card when actual fluid load is less than the pre-calculated fluid load. This can be caused by a tubing or pump leak, a worn out pump, leaky valves or a high tubing-casing annulus fluid level when the net lift, H, has arbitrarily assumed or established at pump depth, L.

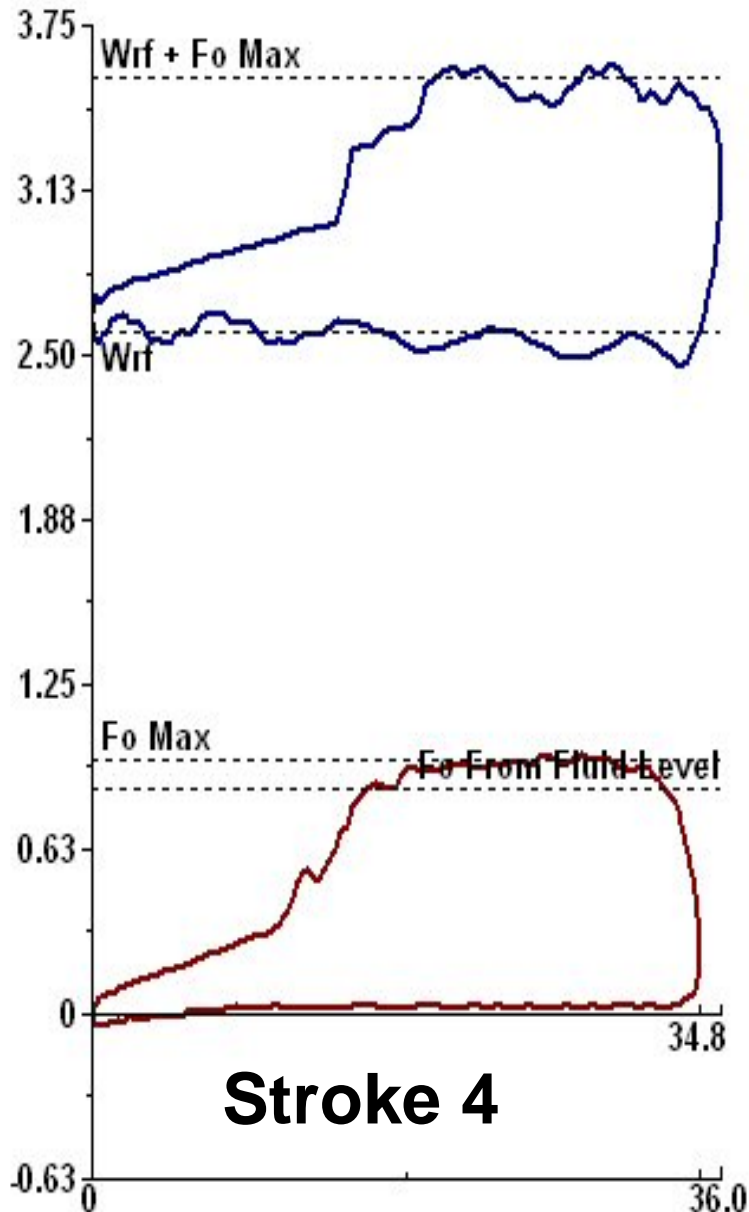
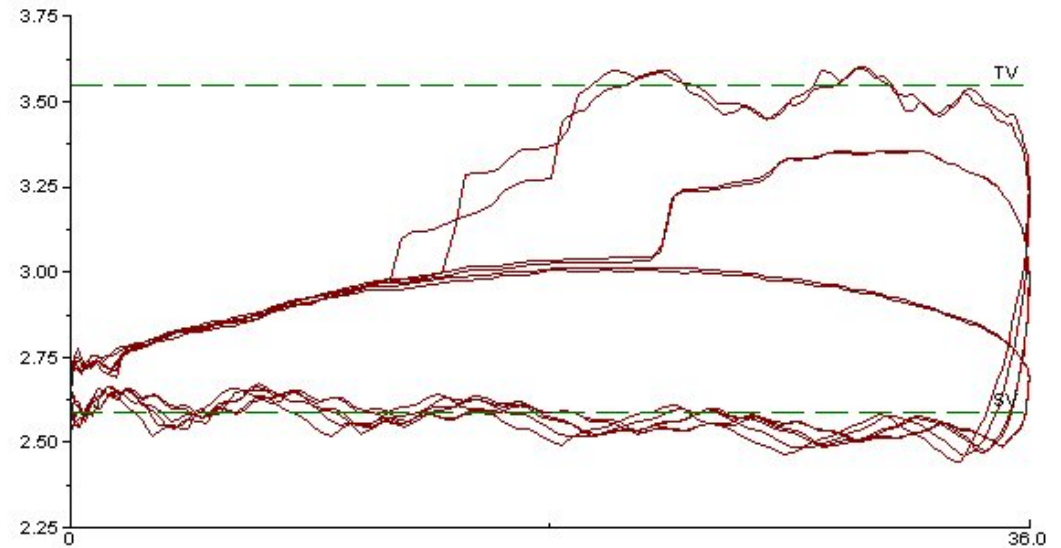
# NO, Damaged TV Ball and seat.

Overlay of many Dynamometer Cards shows each stroke is different.

Worn pump plunger/barrel cards usually overlay.
