**Generalized Synthetic Pump Cards**

**Echometer Help Center  
(Technical Note)**

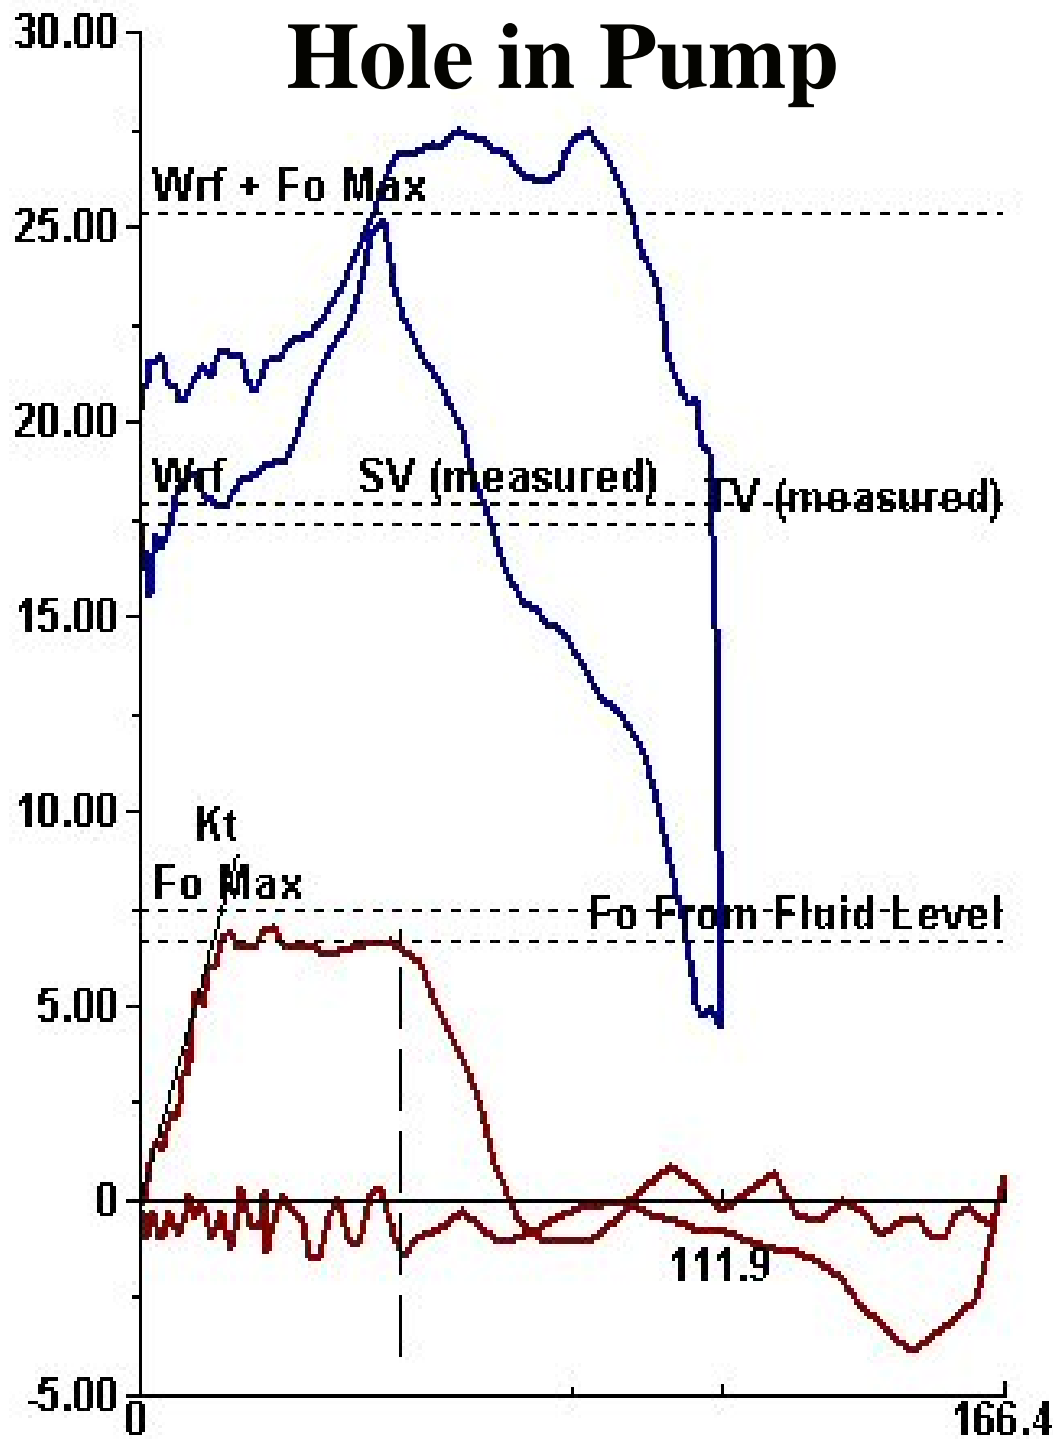
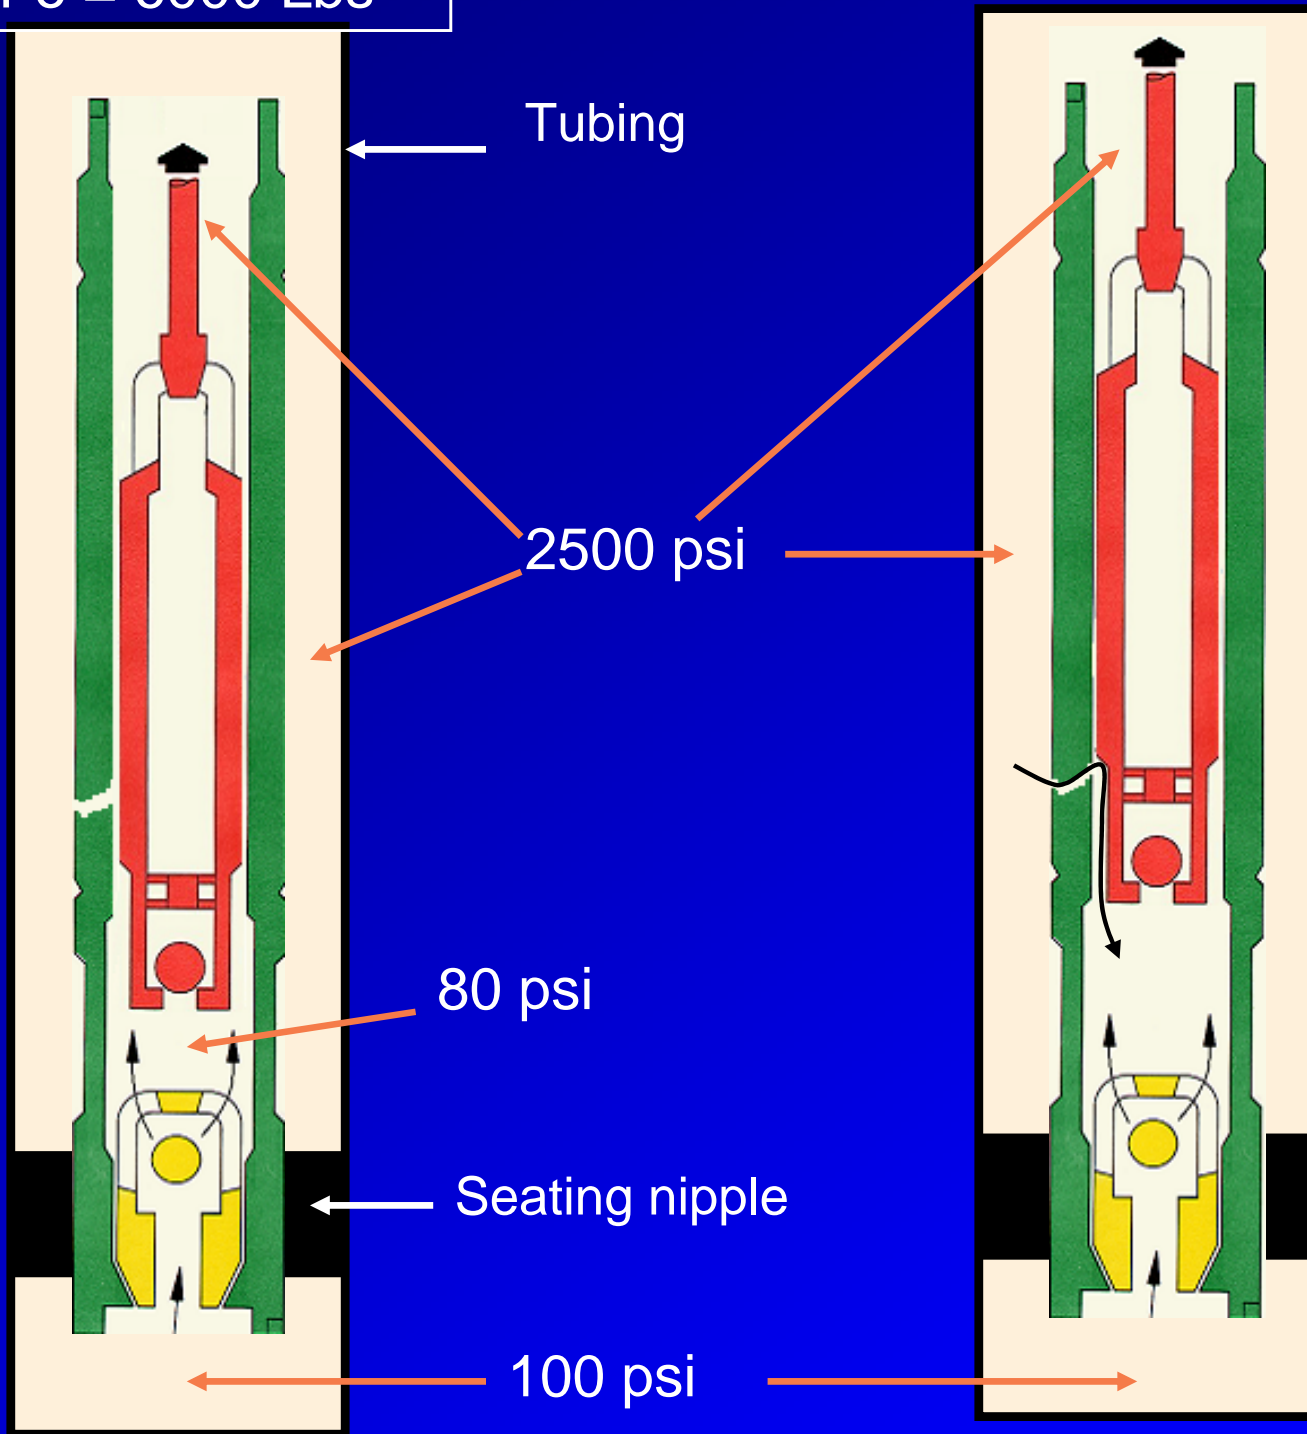
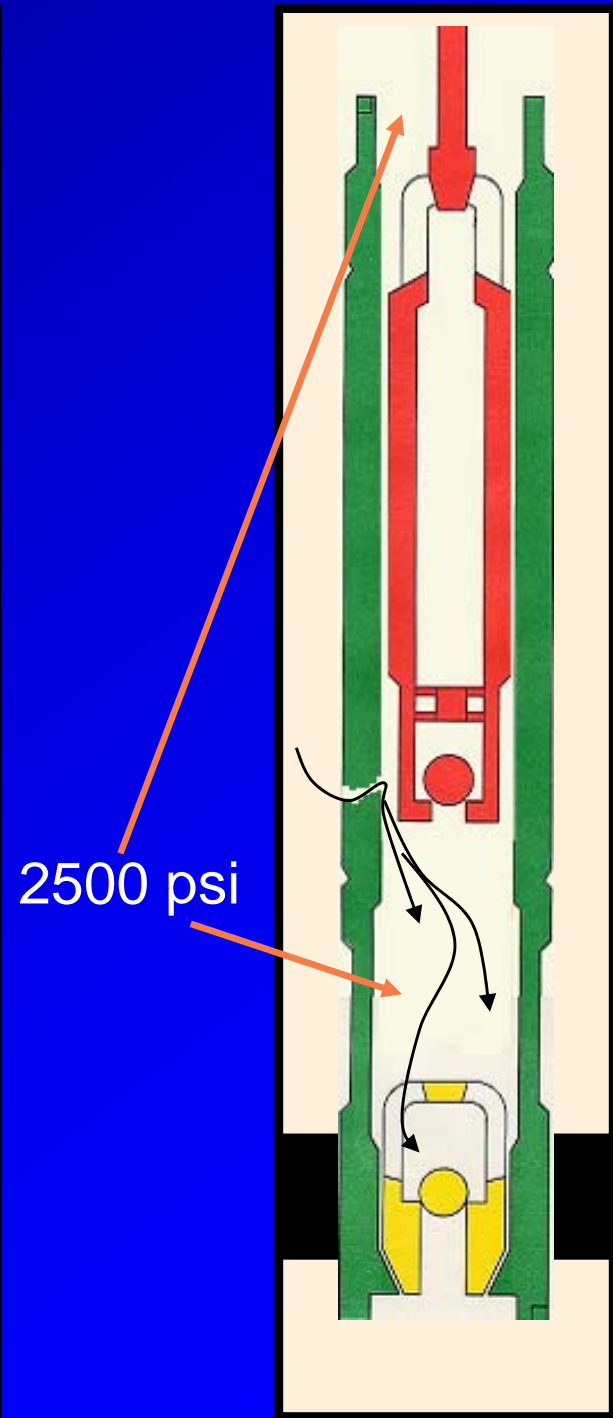
# Hole in Pump

Well has a bottom hold down pump and the tubing anchor is not set. The hole in the pump barrel is about 56 inches from bottom of the stroke.

On the upstroke the fluid load is suddenly lost, which causes a much longer downhole stroke (over travel). When the bottom of the plunger is lifted past the hole, then the tubing pressure leaks between the outside of the pump barrel and the inside of the tubing.

The pumping unit wobbled real bad when on the downstroke, often an indicator of deep parted rods.

TV and SV load checks equal, if stopped early on upstroke the fluid load would have been measured. Don't always stop in same place for valve checks when trying to troubleshoot a problem.

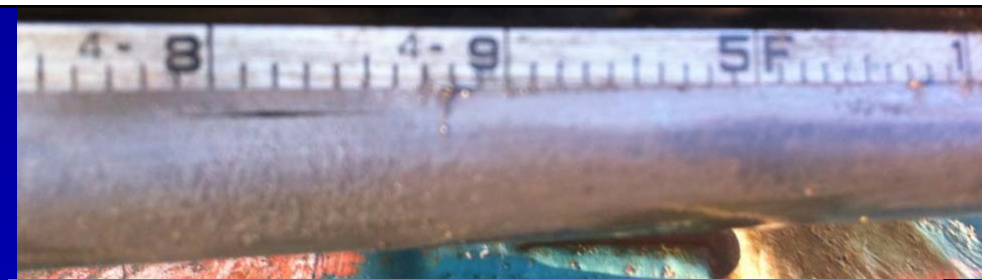
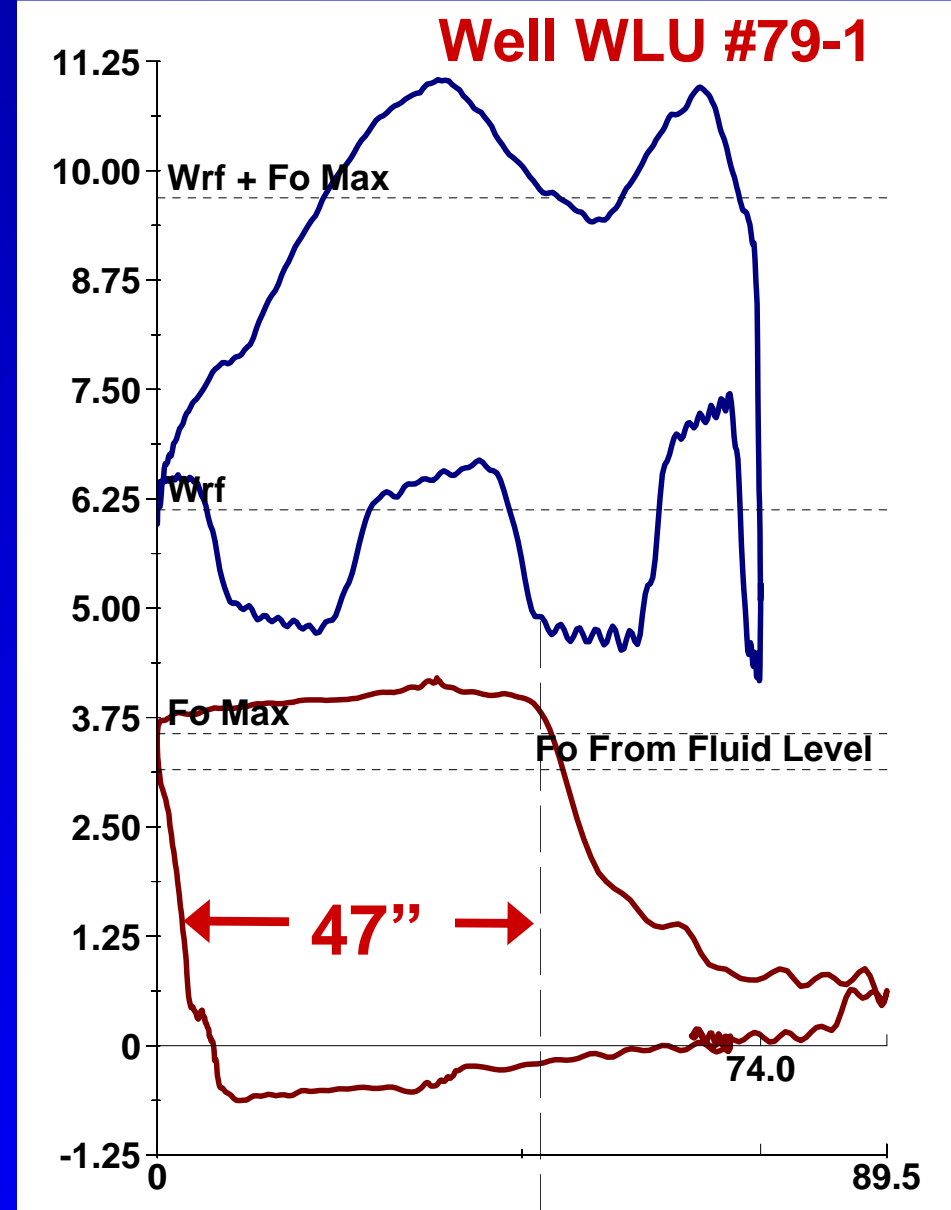
# Hole in Pump Split Barrel @ 4.8 Ft

- Pump Spaced 1 Ft off bottom
- Split Barrel From Fluid Pound
- Pound Damages and Weakens Pump Barrel.

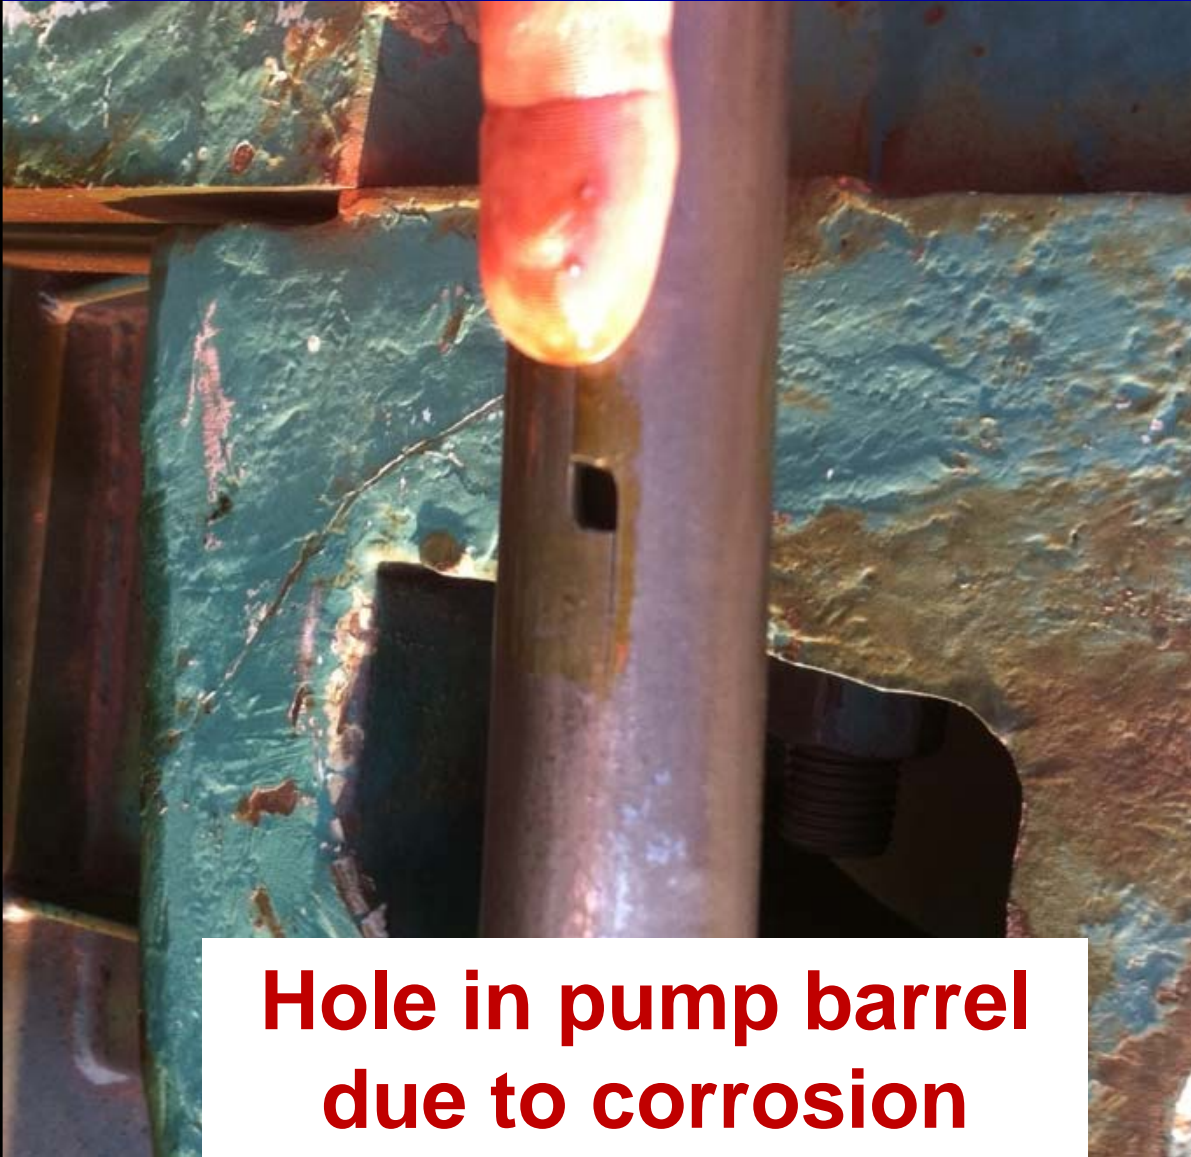
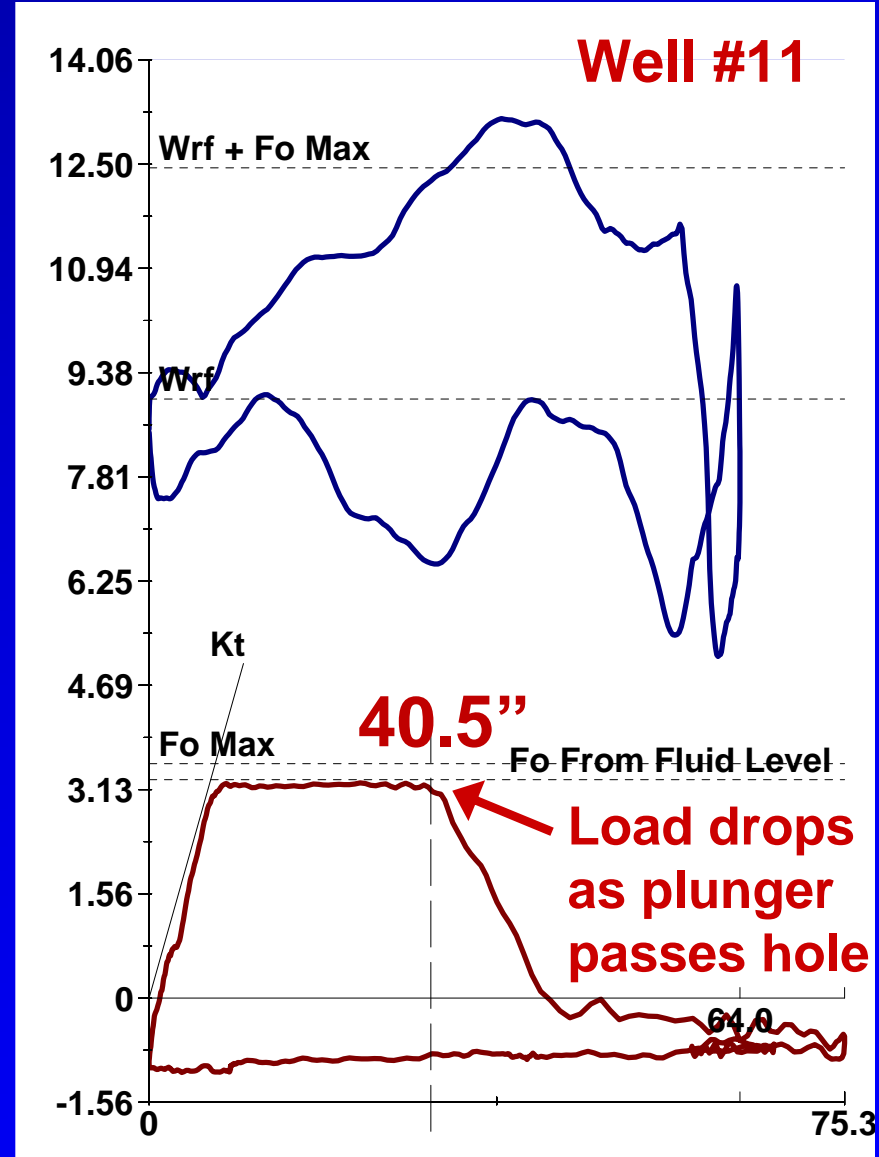
# Hole in Pump Barrel 40.5 Inches From Bottom

Hole in pump barrel due to corrosion

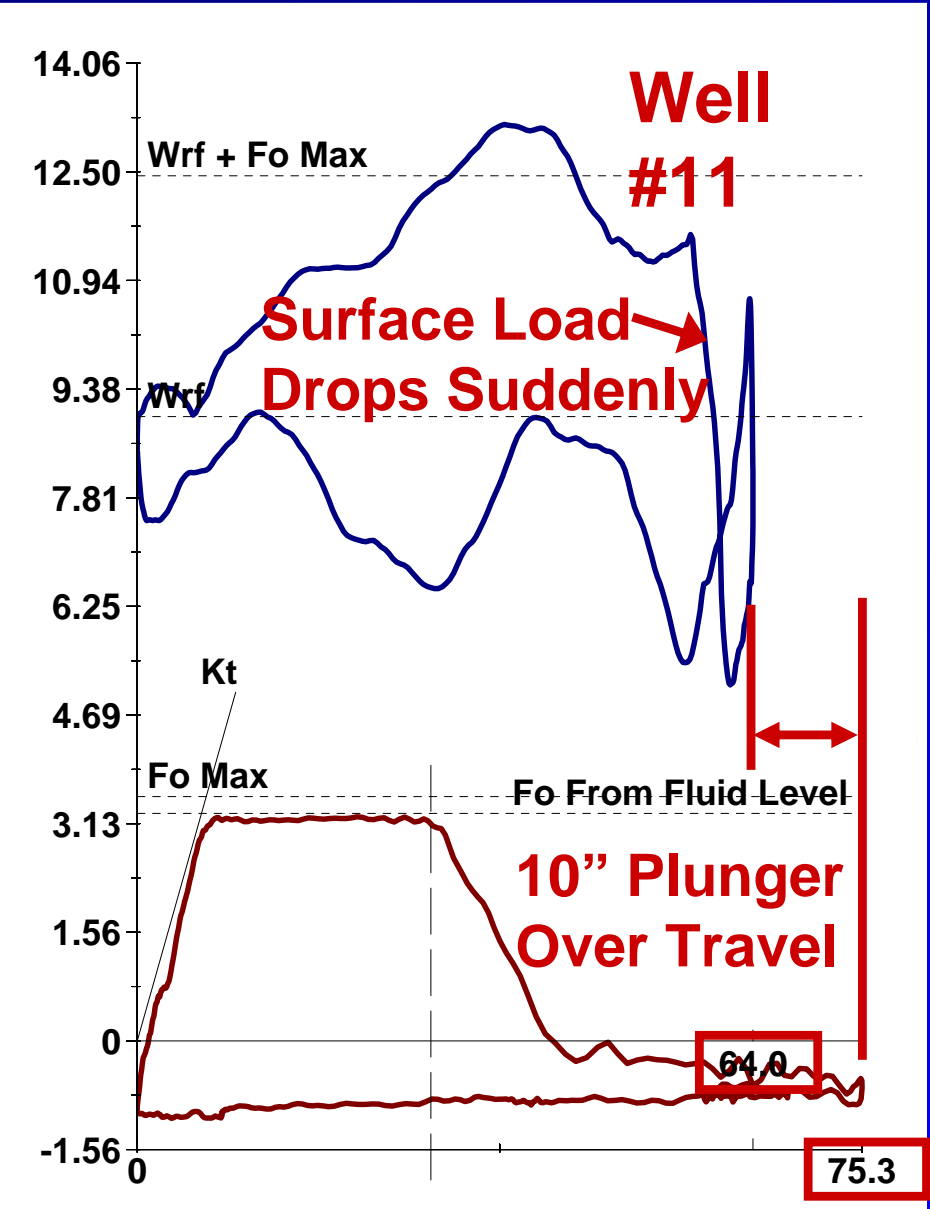
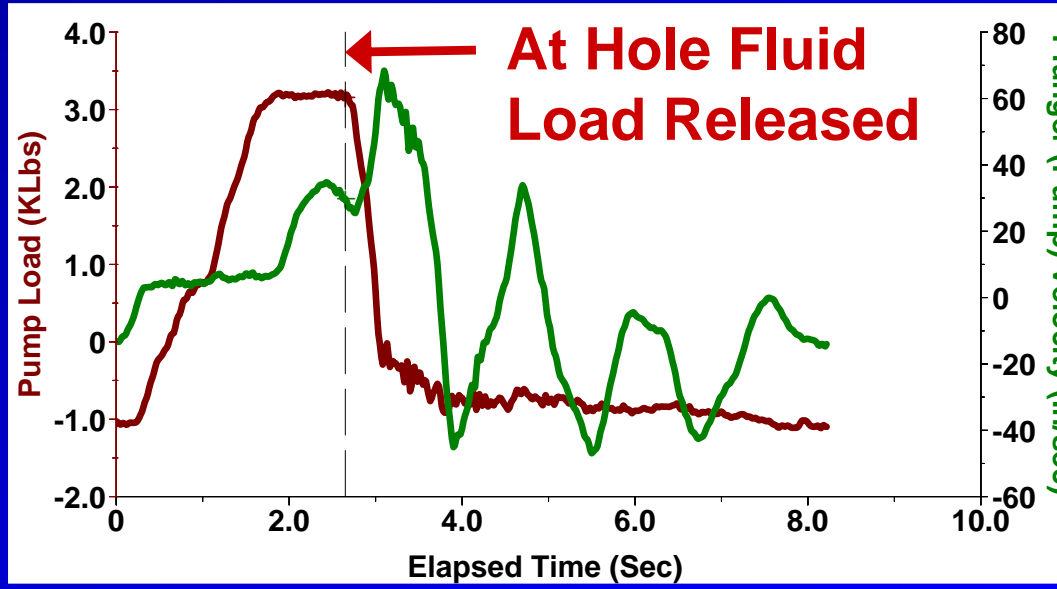
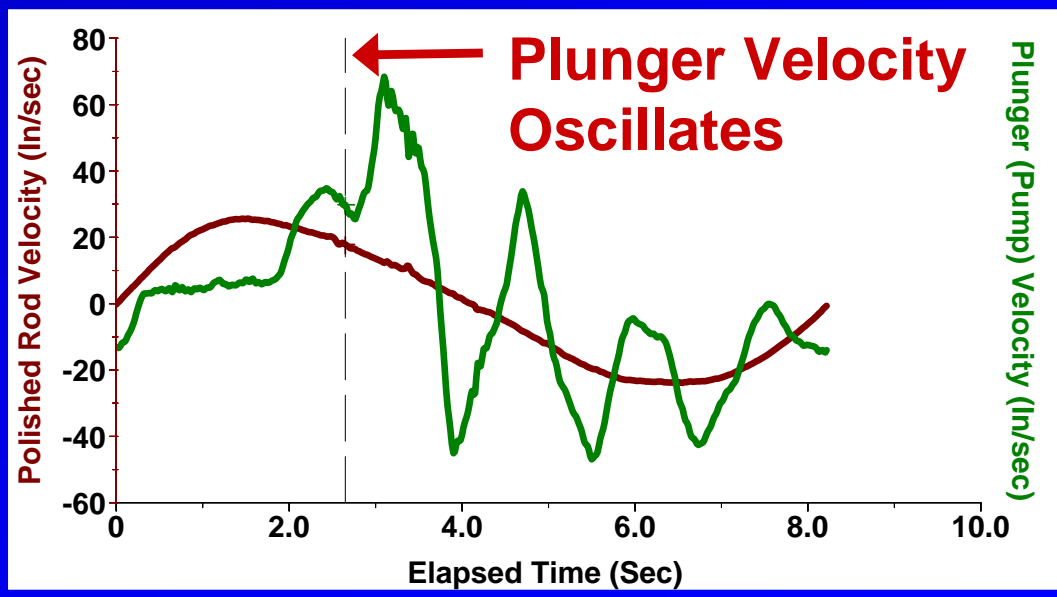
# When the Plunger Goes Past the Hole ~ Fluid Load Released and the Plunger Takes Off

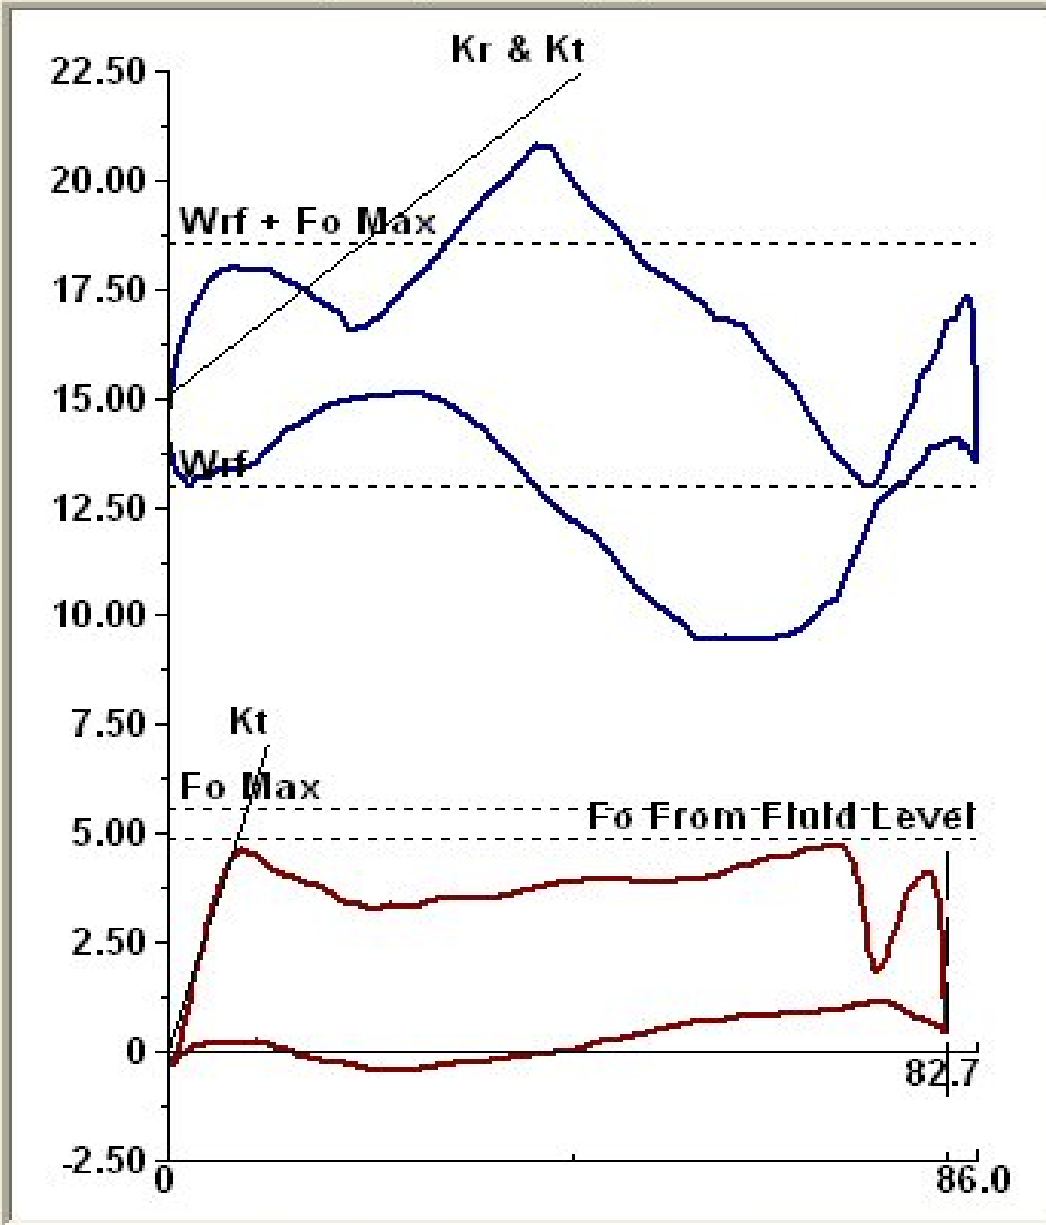
# Worn Barrel

Data was collected on this well because the production to the tank had fallen off.

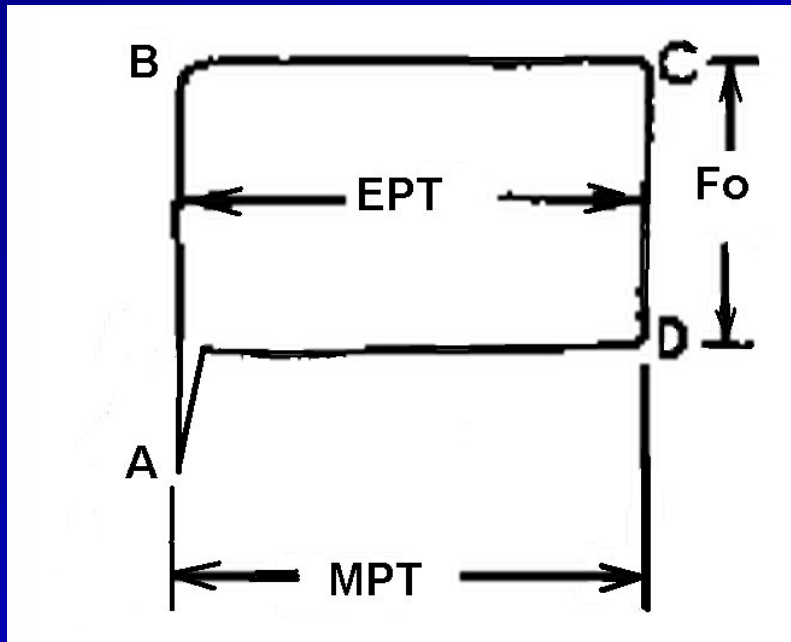
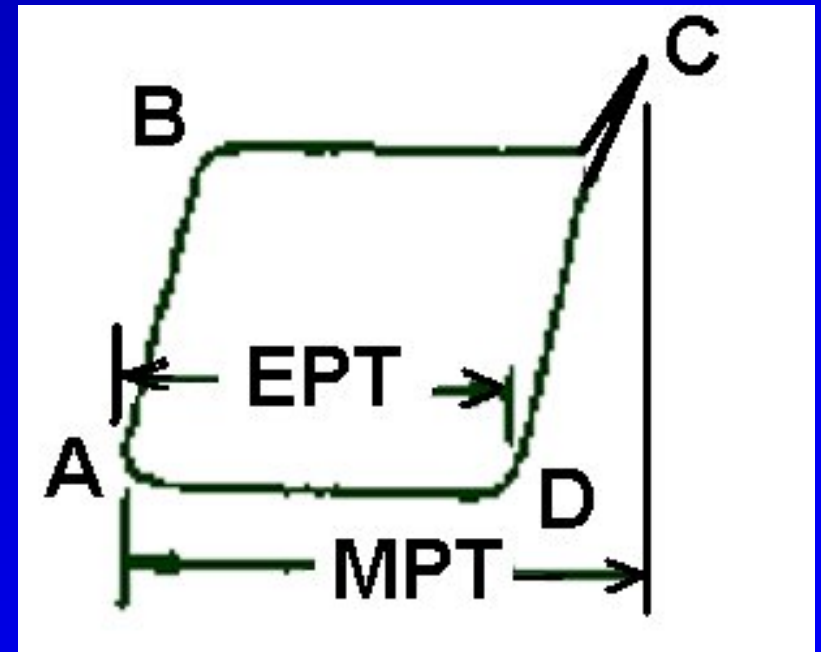
# Synthetic Pump Cards: Improperly Spaced Plunger

Pump is tapping at bottom of stroke(left). Pump is tapping at the top of stroke(right). Damage to pump, rods, and tubing is likely.
