**Generalized Synthetic Pump Cards**

**Echometer Help Center  
(Technical Note)**

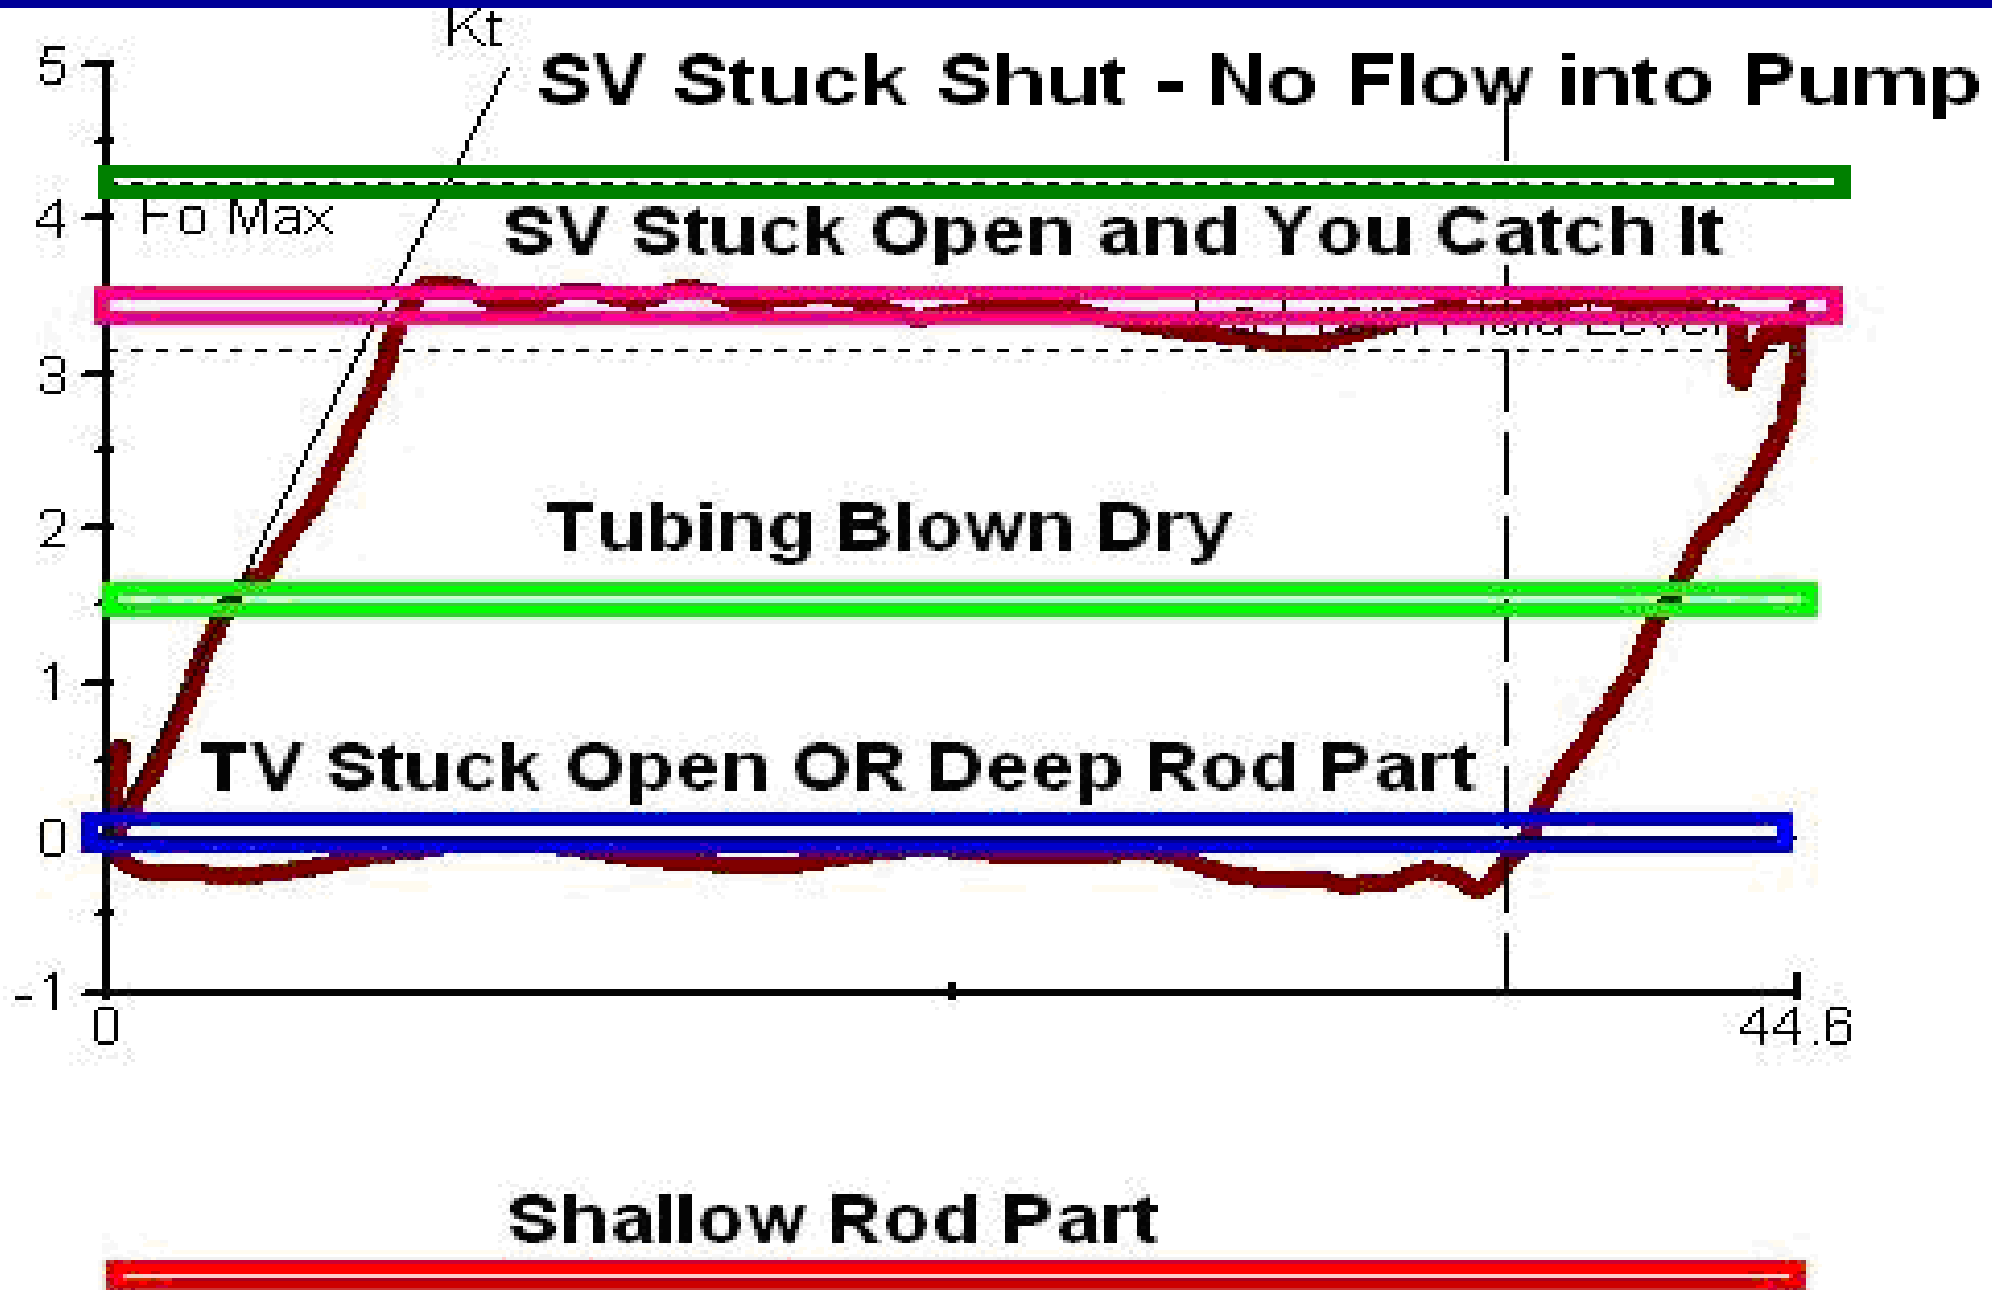
# Horse Shoe Pump Card Flat Load Lines

- 1) TV Stuck Open - Looks like Deep Rod Part but you can often tag or jar the rods and knock the debris out of the pump and re-start pump action.
- 2) Deep Rod Part – Plots on the Zero Load Line
- 3) Shallow Rod Part – Plots below the Zero Load Line by the amount of missing rod weight in fluid no longer attached to the polished rod.
- 4) Tubing Blown Dry – Plots as a flat line @ a height of Wra-Wrf pounds above the zero load line.
- 5) SV Stuck Open – Plots on the Fo from the Fluid Level line.
- 6) Blocked Intake – No fluid entry into pump and low slippage through pump clearances

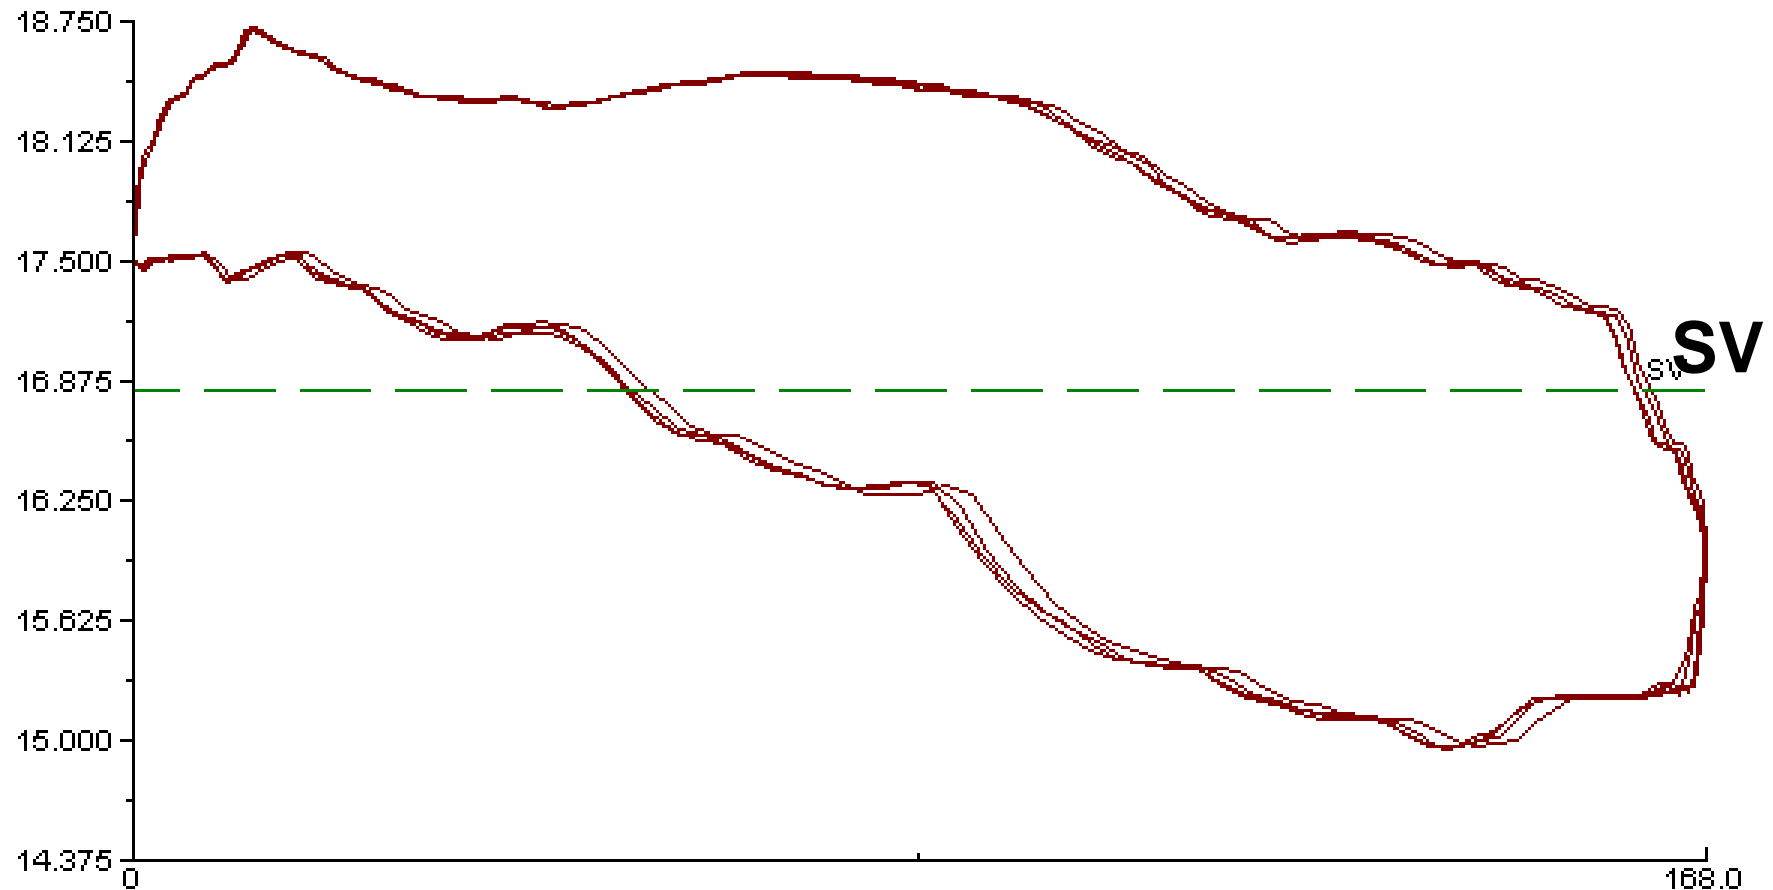
HT011

**Trash in TV** Notice normal appearing Surface Dynamometer Card, on the 13<sup>th</sup> stroke TV became stuck open due to trash. Same type of surface card could occur, if Pump unseated, Pull Rod became unscrewed or parted, or rods parted at the pump.

# Surface card OK. Pump OK?

Sometimes trash in the pump keeps the traveling valve ball from going on seat. Tagging on the down stroke before pulling, may knock out trash.

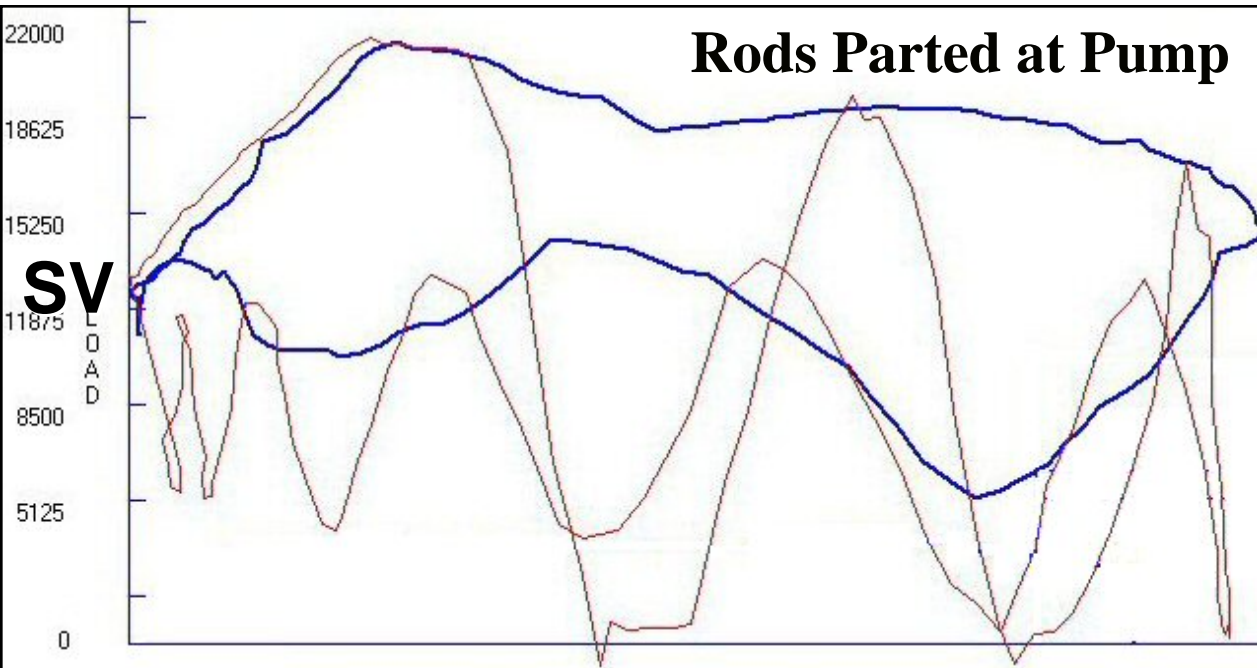
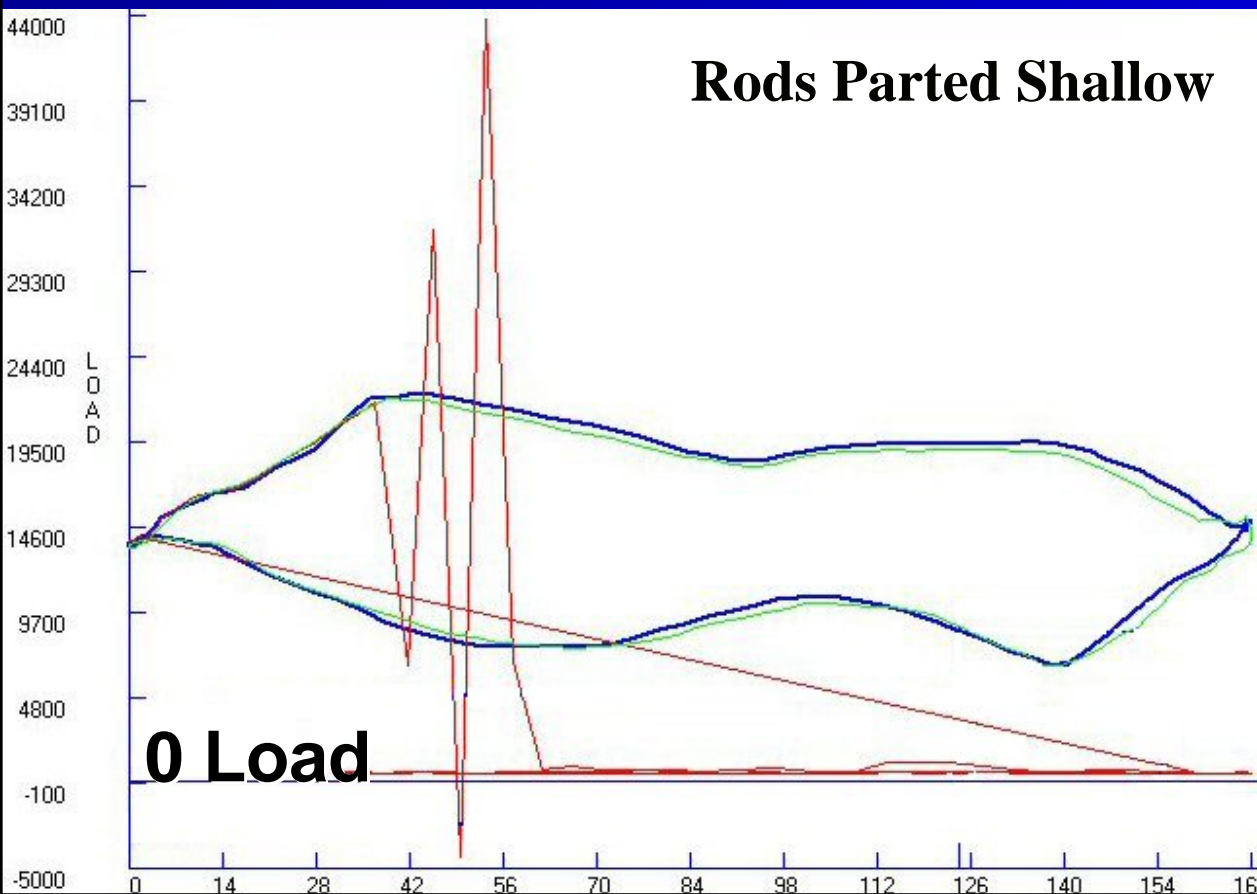
TV Stuck Open	Tubing Dry
Deep Rod Part	SV Stuck Open
Shallow Rod Part	Blocked Intake

- 3) OK Pump Card should plot between Zero Load Line and Fo from Fluid Level Line
- 4) If Polished Rod Transducer used to acquire dynamometer data **and pump card is flat**
  - Difficult to identify problem
  - All of the loads plot on the zero load line.

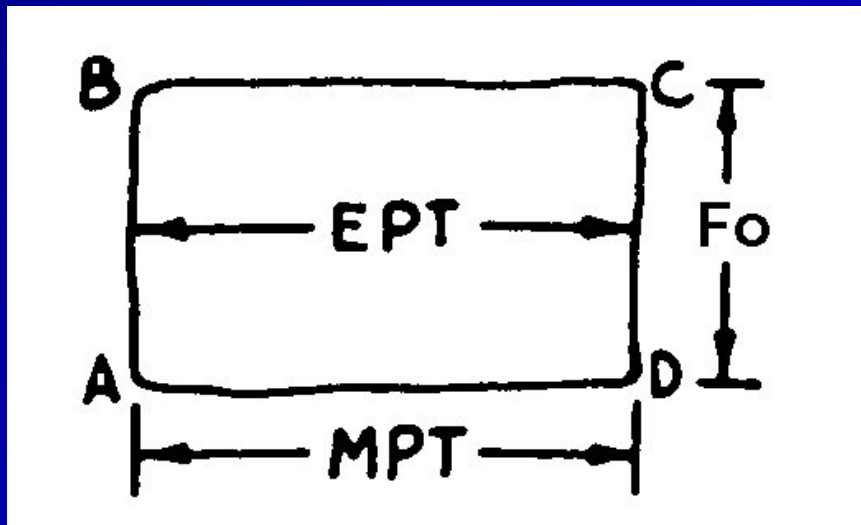
Tubing anchored,  $EPT=MPT$ .

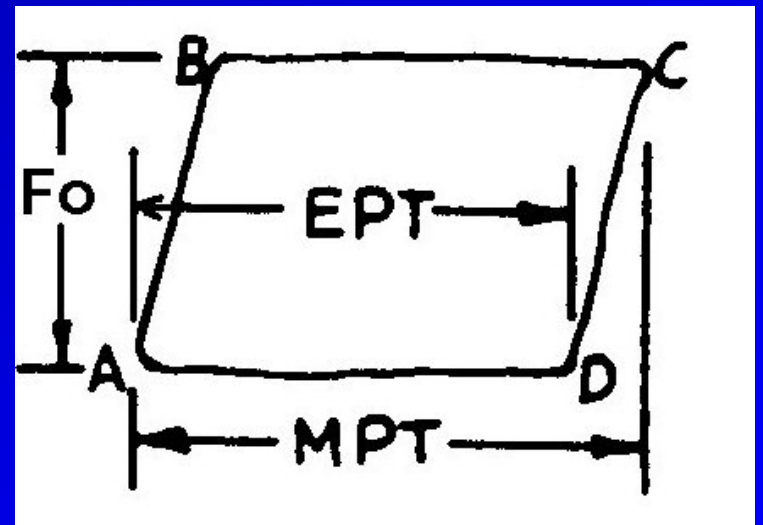
Unanchored tubing,  $EPT < MPT$

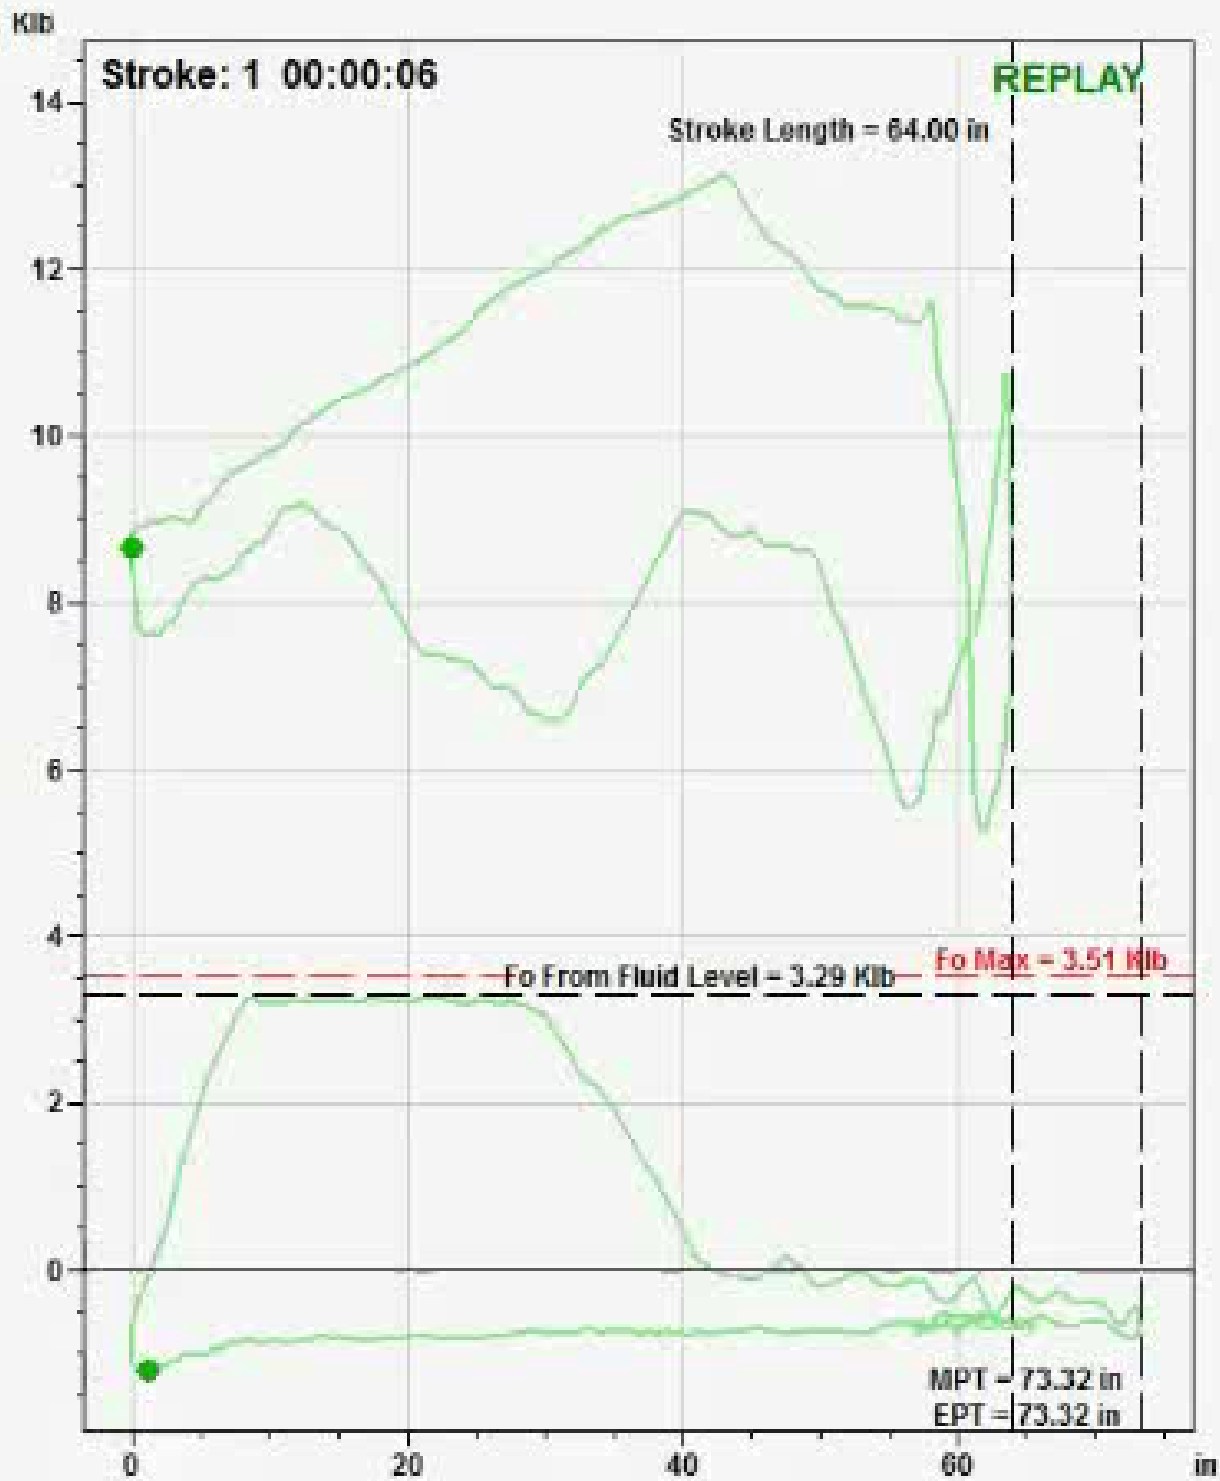
On the upstroke the fluid load is suddenly lost, which causes a much longer downhole stroke (over travel). When the bottom of the plunger is lifted past the hole, then the tubing pressure leaks between the outside of the pump barrel and the inside of the tubing.

Hole in pump barrel due to corrosion

# When the Plunger Goes Past the Hole ~ Fluid Load Released and the Plunger Takes Off
